## TEST REPORT

LWR NO.: 16438 DATE: Dec. 2, 2005

**Sample ID:** J-M Mfg. Co., Inc. 18" PVC Blue AWWA C905 DR25 Pipe

### TEST PROCEDURES: Failure analysis

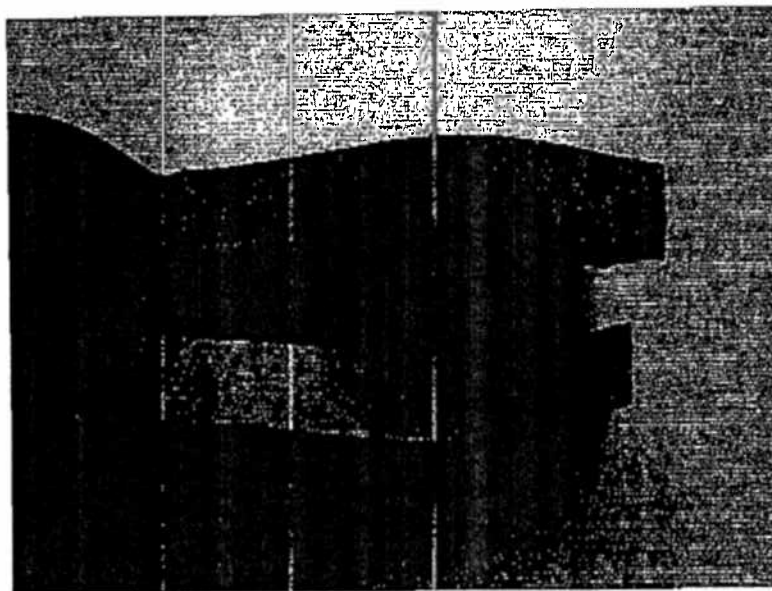
The fracture is unmistakably a fatigue type failure with fatigue failure beach marks. A line through the fracture is a ratchet caused by two origins that grew on each side. See Photos 7 – 11.

Only two origins were observed. The area was examined for additional cracks on each side of the origins but none were observed. The lack of more cracks shows the stress was localized at this area due primarily to bending.

**Photo 7:** Both sides of the initial fracture

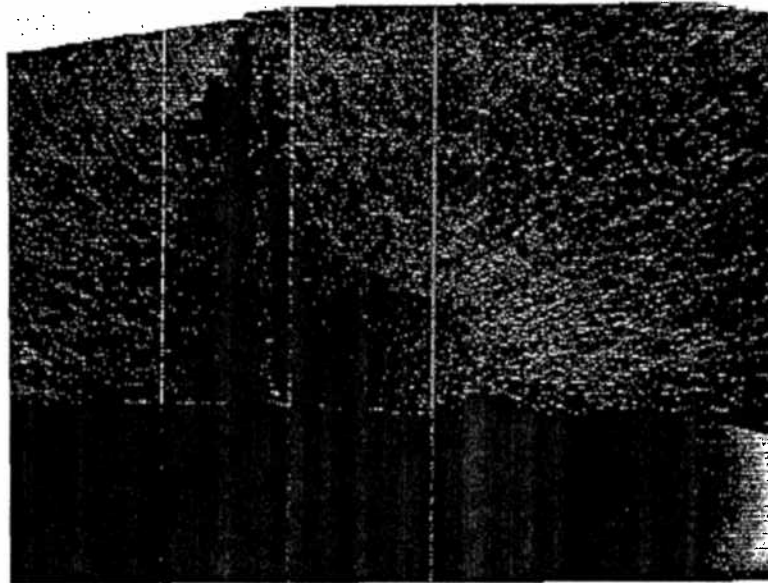
**Photo 9:** Striations typical of a fatigue fracture, inside surface facing down

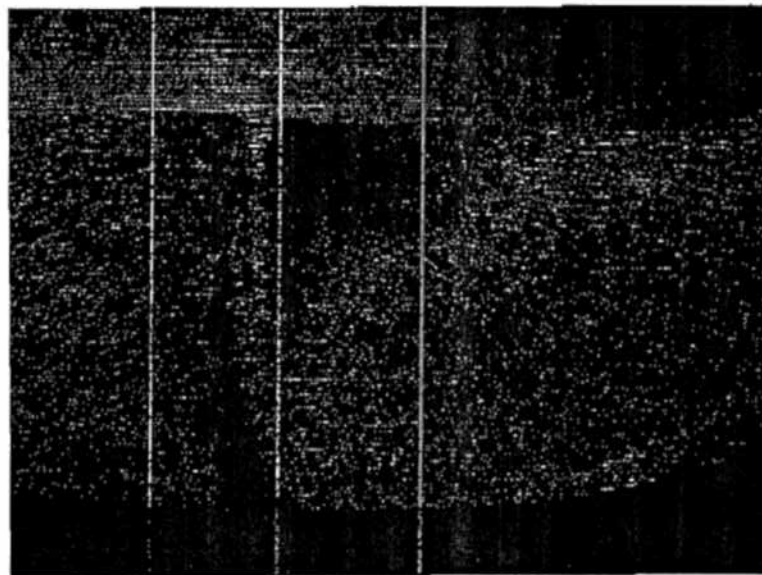
**Photo 10:** Opposite side of fracture, inside surface facing up
