Sustainable**Solutions**  
CORPORATION

**APRIL 2017**

## **LIFE CYCLE ASSESSMENT OF PVC WATER AND SEWER PIPE AND COMPARATIVE SUSTAINABILITY ANALYSIS OF PIPE MATERIALS**

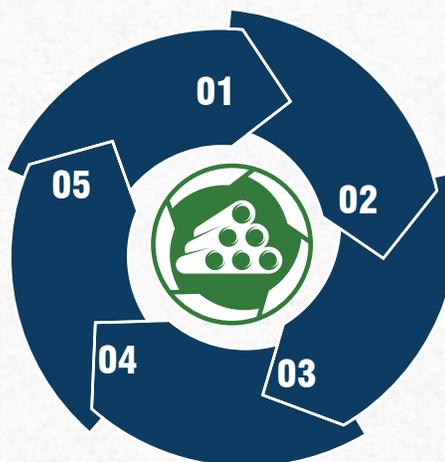
**FIGURE 3.1 : LIFE CYCLE OF PVC PIPE**

Typical cradle-to-grave life cycle stages, as shown in Figure 3.1, include:

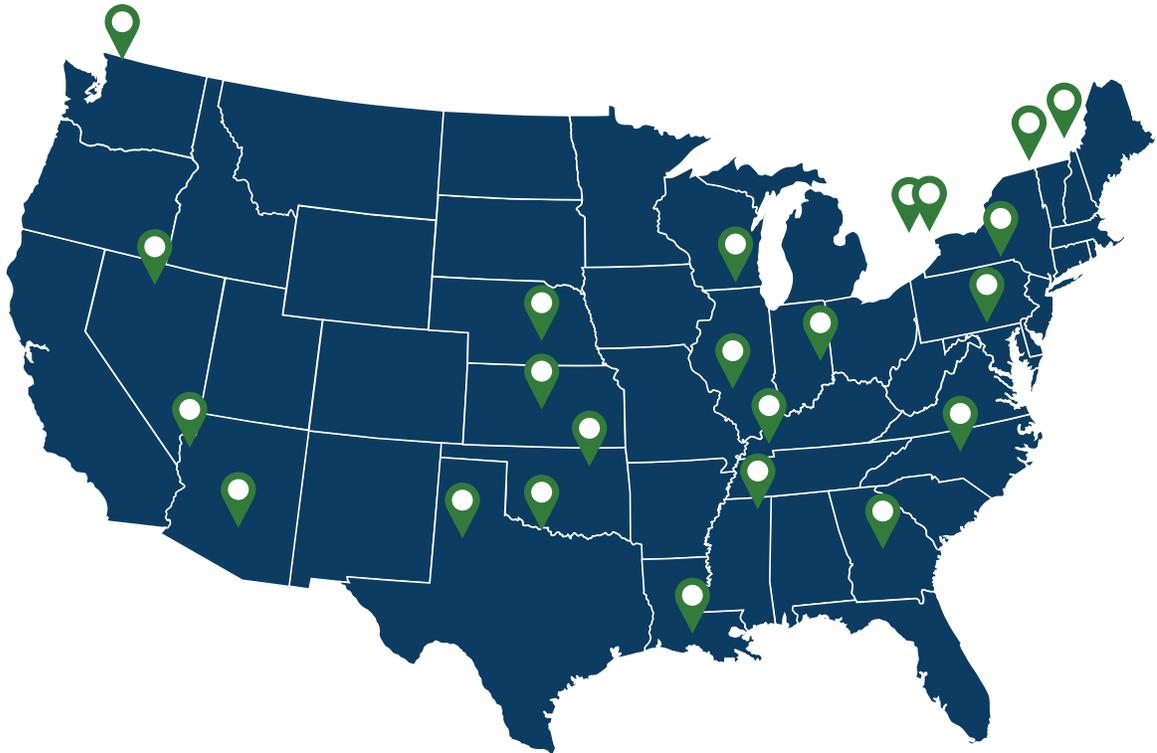
**FIGURE 3.2 : MAP OF PARTICIPATING PVC PIPE FACILITIES FOR LCA**

This study used data from 23 facilities of members of the Uni-Bell PVC Pipe Association (see Table 3.2 for participating companies), representing roughly 22% of all PVC pipe manufacturing plants in the United States and Canada (see Figure 3.2). Table 3.3 lists the number of manufacturing facilities that submitted primary data for each of the seven pipe types analyzed.

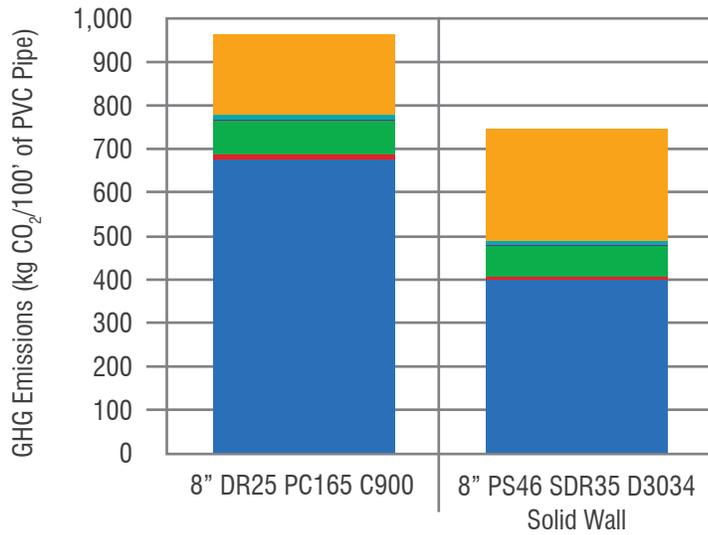
**FIGURE 4.2 : OVERALL CRADLE-THRU-INSTALLATION LIFE CYCLE GHG EMISSIONS IMPACT OF PVC PIPE (KG CO<sub>2</sub> EQ PER 100')**

For these two piping products, the raw materials stage is the main driver of impacts; however, the installation stage is also a large driver of GHG emissions.

- INSTALLATION
- FINAL PRODUCT TRANSPORTATION
- PACKAGING
- PIPE MANUFACTURING
- RAW MATERIAL TRANSPORTATION
- RAW MATERIALS

Only a modest amount of energy is required for the extrusion of PVC pipe, so manufacturing is a small contributor towards GHG emissions in the cradle-through-installation analysis. Table 4.2 and Figure 4.2 show the GHG emissions for the various life cycle stages of PVC potable water and sewer pipes. Table 4.3 and Figure 4.3 show the TRACI environmental impacts for 8-inch PVC DR25 PC165 AWWA C900 PVC pressure pipe. See Table 4.4 and Figure 4.4 for the TRACI environmental impacts for 8-inch PVC PS46 SDR35 ASTM D3034 solid-wall sanitary sewer pipe.

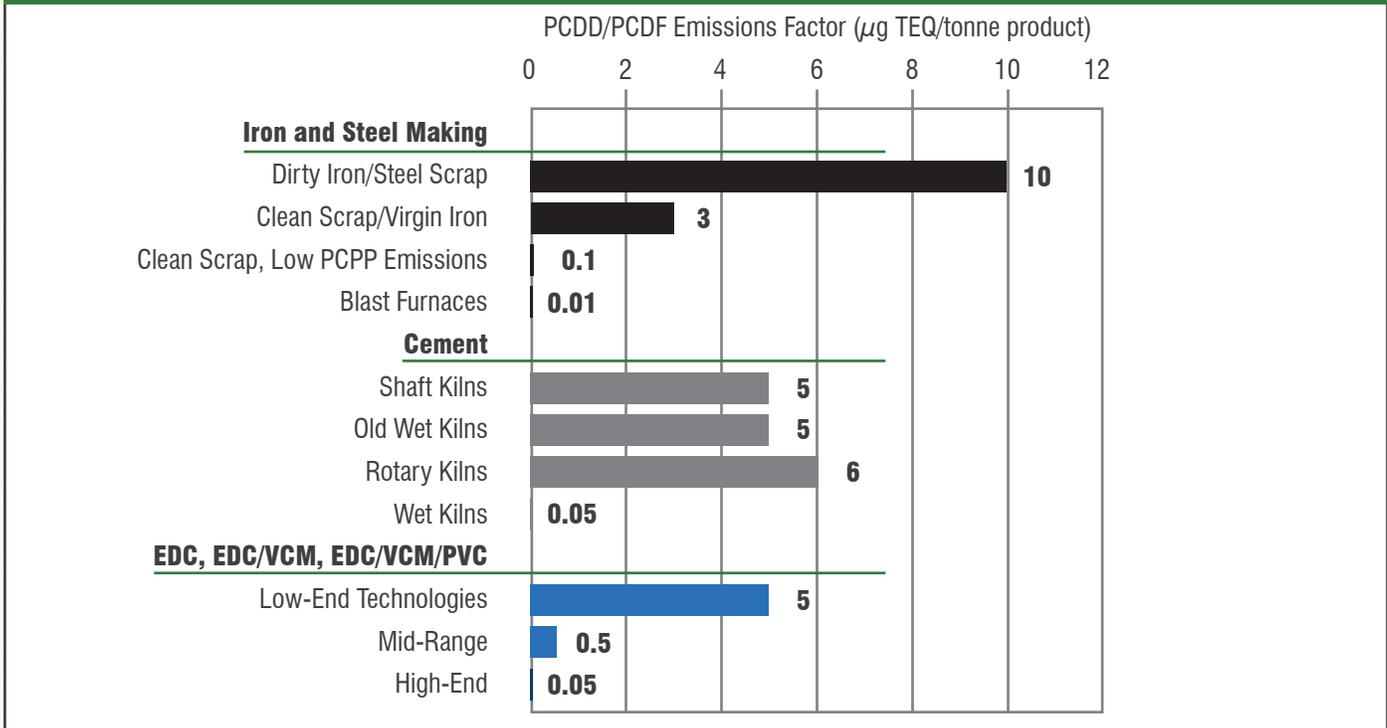
**FIGURE 5.1 : UNEP ESTIMATED DIOXIN EMISSIONS FACTORS FROM GIVEN PRODUCTION SOURCES**

According to the EPA and the United Nations Environment Programme (UNEP), metal sintering and magnesium production (both used in steel and iron production) and coal-fired electricity production are also major sources of dioxin emissions.<sup>30 31 32</sup> UNEP has standard emissions factors for facilities that are major sources of dioxin emissions.<sup>33</sup> A sample of these factors is shown in Figure 5.1. GreenSpec® has removed cast-iron drain pipe from their listings because of the high embodied energy and pollution emissions from coking plants.<sup>34</sup>

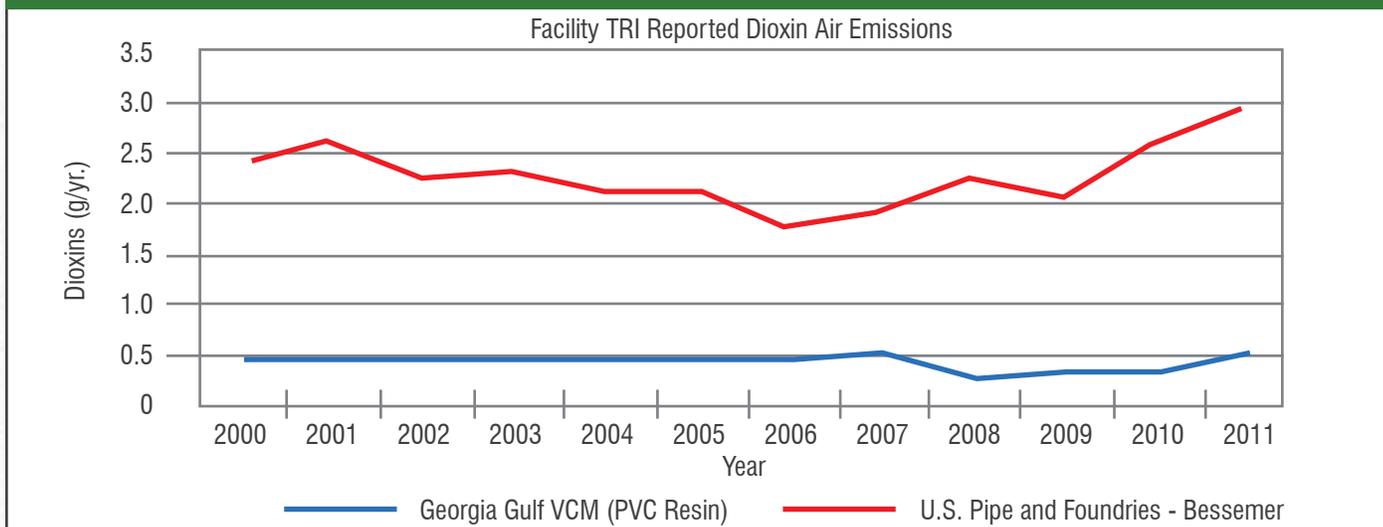
**FIGURE 5.2 : ANNUAL DIOXIN AIR EMISSIONS FROM A VCM PVC RESIN PLANT AND A DUCTILE IRON PIPE PLANT TO THE U.S. EPA TOXIC RELEASE INVENTORY**

Dioxin emissions are tracked by the U.S. EPA through the Toxic Release Inventory (TRI). TRI data are made publicly available. Figure 5.2 is a sampling of the dioxin air emissions reported by a VCM (PVC resin) manufacturer and a ductile iron manufacturer.<sup>35</sup>

As shown in Figure 5.2, the PVC resin facility reports less dioxin emission than the ductile iron plant. This illustration confirms that dioxin emission are also a concern for other piping materials.

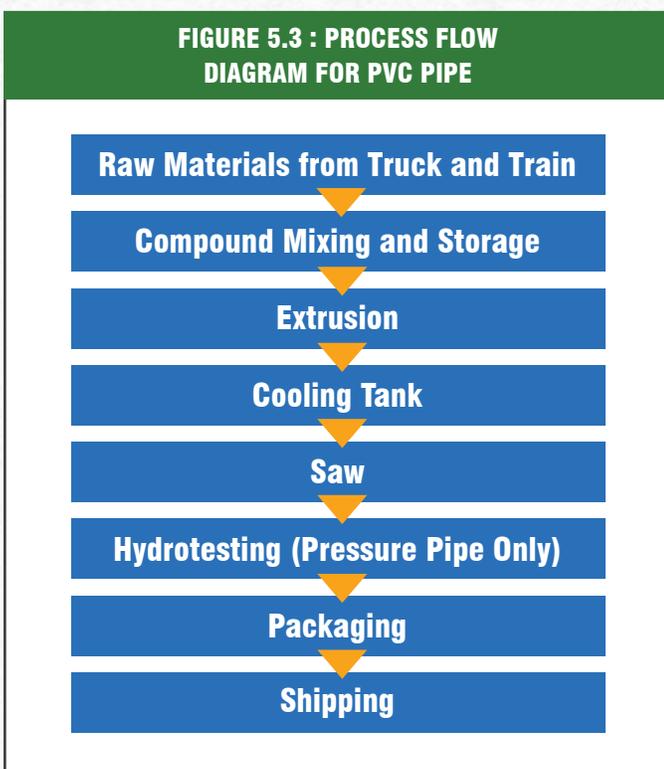
**FIGURE 5.3 : PROCESS FLOW DIAGRAM FOR PVC PIPE**

technology demonstrates the PVC pipe industry's commitment to continuous improvement and efficiency. After the cooling process, pipes are cut into standard lengths with an electric saw, and one end of each pipe is put into a belling machine to achieve the bell shape. Every standard length of pipe used in municipal potable water systems is pressure-tested on the production line. The finished pipes are then arranged onto wood frames and strapped into place, loaded onto a truck or train car, and shipped to a distributor or job site. Almost all scrap material is ground and fed back into the extruder, resulting in very little waste. The manufacturing process uses small amounts of electricity and results in almost zero emissions. Figure 5.3 outlines the steps involved in the PVC pipe manufacturing process.

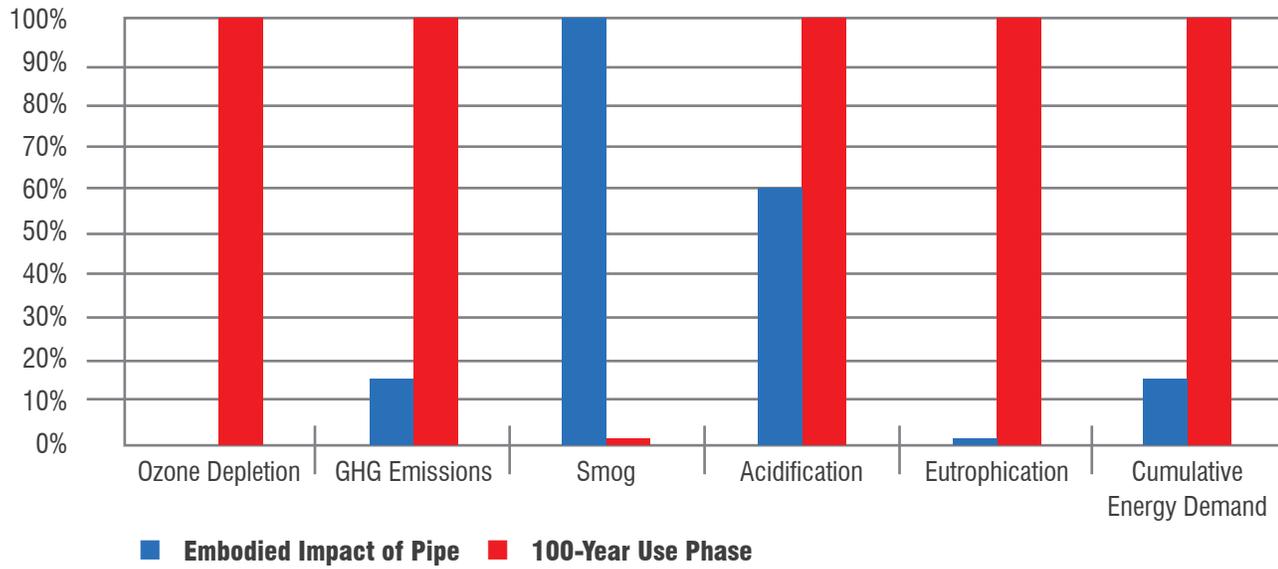
**FIGURE 7.1 : ENVIRONMENTAL IMPACTS OF THE USE PHASE OF 8” PVC DR25 PC165 C900 PIPE VS. EMBODIED IMPACTS OF THE PIPE**

Table 7.1 and Figure 7.1 show the environmental impacts of the cradle-through-installation of 8-inch PVC DR25 pipe compared to the use-phase impacts for 100 years of pumping energy at a constant water flow of 336 gallons per minute (gpm), with a pump energy efficiency of 75%. The flow rate of 336 gpm is equal to a flow velocity of 2 feet per second (fps) in an 8-inch PVC DR25 pipe. Because water demand is based on volumetric flow rate, the same flow rate of 336 gpm was used for comparison of all the 8-inch PVC DR25 pipe alternatives. The same methodology was used for comparison of the 8-inch PVC DR18 and the 24-inch PVC DR25 pipe alternatives.

The use phase of the pipe life cycle dominates as the primary cause of environmental impacts of PVC pipe with the exception of smog which is primarily caused by production of electricity and burning of fuel in the pipe installation equipment and from raw materials extraction and production.

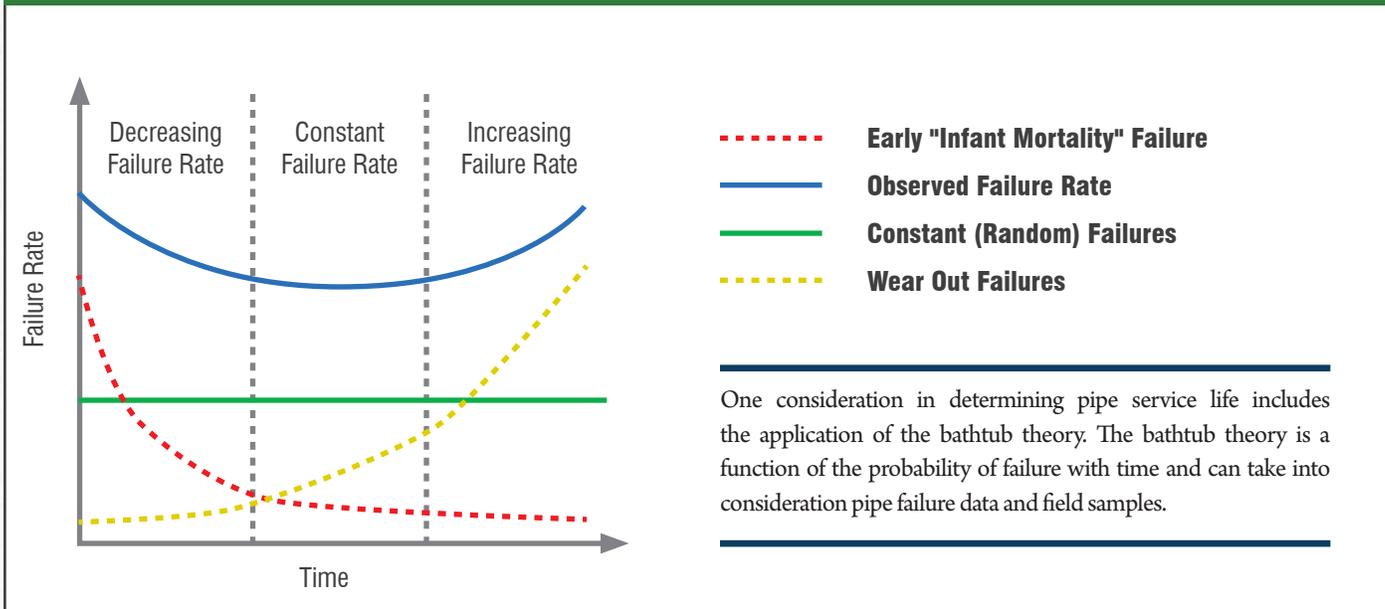
FIGURE 8.1 : APPLYING THE “BATHTUB” THEORY TO DETERMINING PIPE SERVICE LIFE

One consideration in determining pipe service life includes the application of the bathtub theory. The bathtub theory is a function of the probability of failure with time and can take into consideration pipe failure data and field samples.

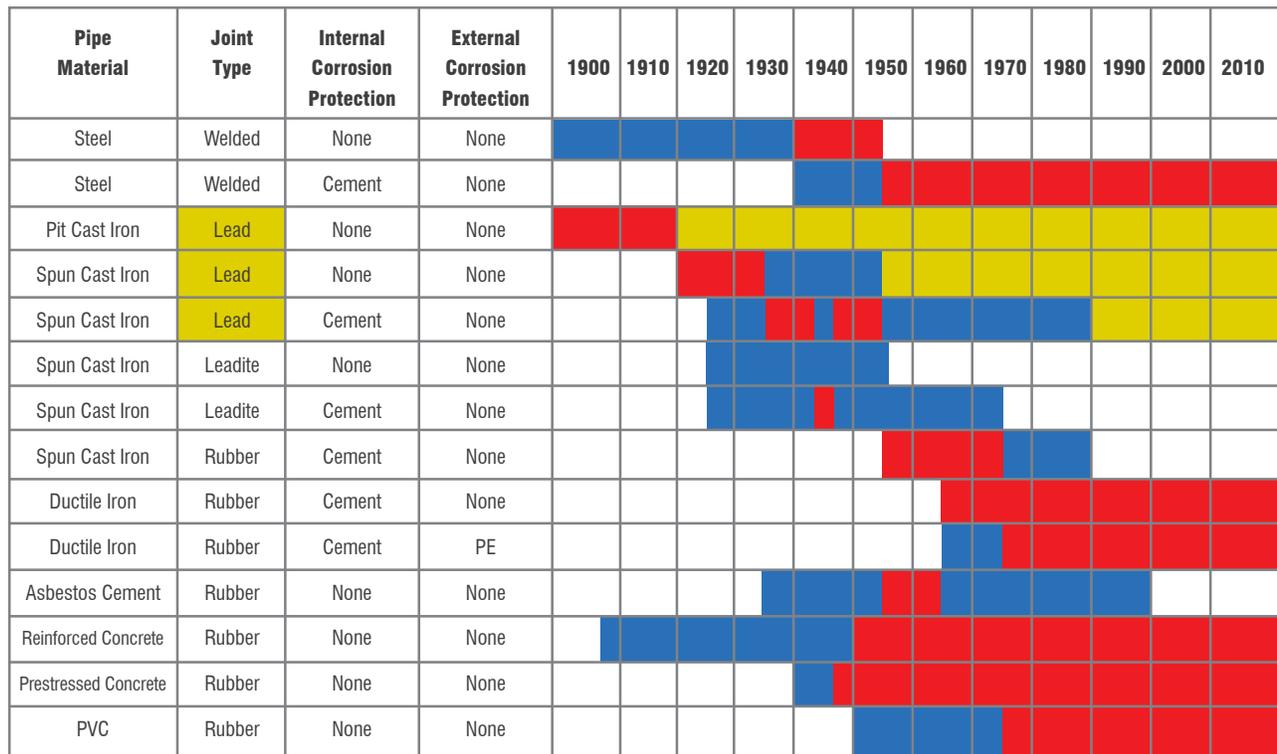
FIGURE 8.3 : TIMELINE OF PIPE TECHNOLOGY IN THE U.S. IN THE 20<sup>TH</sup> CENTURY

- Pipe Material Availability
- Periods of Material Availability and Use
- Extended Potential Lead Joint Leaching Periods in Iron Pipes

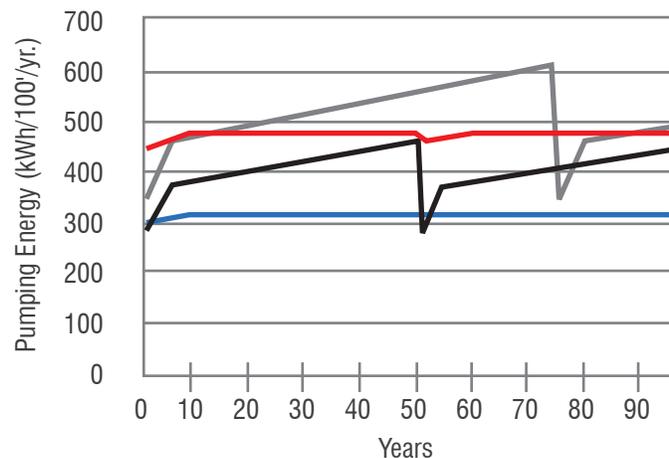
- PVC PC165
- DI PC200
- PCCP PC200
- HDPE PC160

*Note: Graph assumes replacement of DI pipe at 50 years, PCCP at 75 years and HDPE at 50 years.*

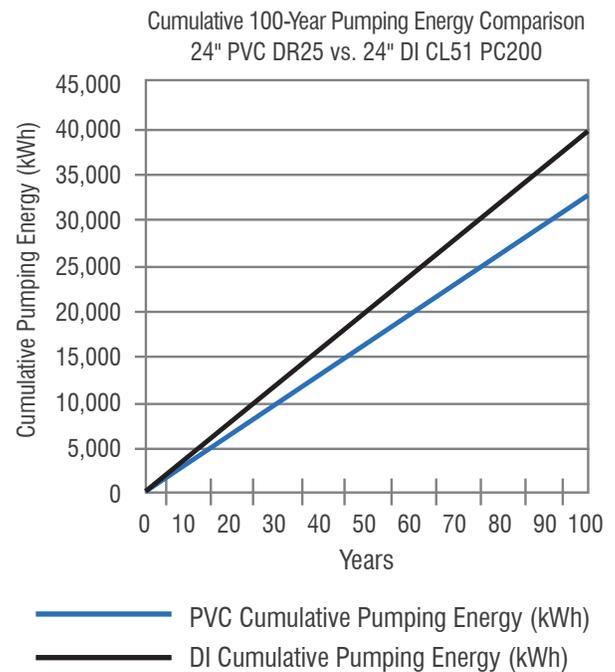
**FIGURE 9.2 : COMPARISON OF CUMULATIVE 100-YEAR PUMPING ENERGY FOR 24" PVC AND DI PIPE**

Note: Graph assumes replacement of DI pipe at 50 years.

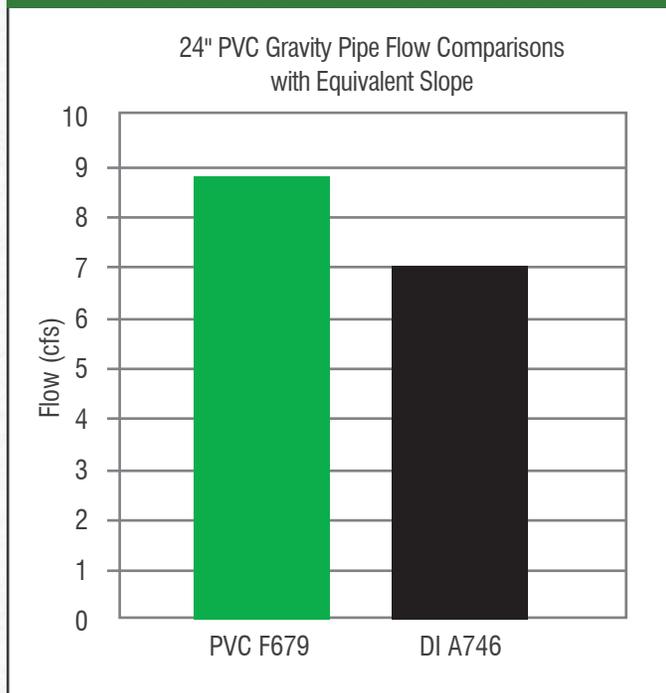
**FIGURE 9.3 : FLOW COMPARISON WITH EQUIVALENT SLOPE OF 24" SOLID-WALL PVC AND DI PIPE**

As shown in Figure 9.3, the flow is about 20% more for a 24-inch PVC pipe than a 24-inch ductile iron equivalent pipe when installed with the same slope.

Similarly, the DI pressure pipe standard, AWWA C151, does not require joints to be tested for external pressure/internal vacuum. This is an important water quality issue considering that leaky pipes can allow potential contaminants into the water system during a dynamic pressure drop (pump or valve failure, firefighting, or other sudden demand changes on the system), which could allow contaminated ground water to enter the pipe.<sup>119</sup> For gravity pipes the deterioration of the interior walls of DI pipe causes a greater resistance to flow and a higher Manning's n factor. The greater hydraulic friction inside DI pipe means that a DI gravity pipe laid on the same slope as a PVC pipe will have less hydraulic capacity. Figure 9.3 compares the flow of 24-inch PVC and DI pipes on the same slope.

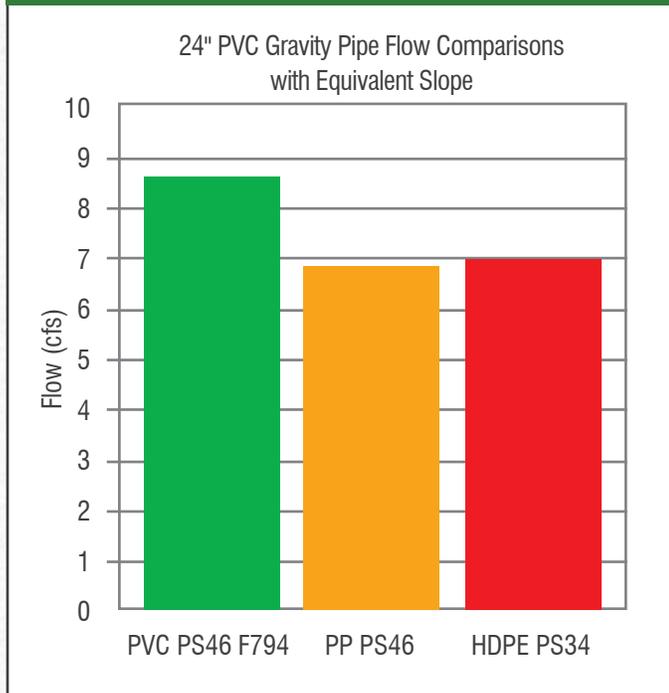
**FIGURE 9.7 : FLOW COMPARISON WITH EQUIVALENT SLOPE OF 24" PVC, PP AND HDPE PROFILE-WALL PIPES**

HDPE and PP pipes are subject to strain creep. Strain creep is a property of some materials whereby, when subjected to a load, the pipe will continue to slowly flex under the load over time. For buried HDPE and PP gravity pipes, strain creep means that the pipes will continue to deflect over time. The standards for HDPE and PP gravity pipes make allowances for strain creep over the expected lifetime of the pipes.

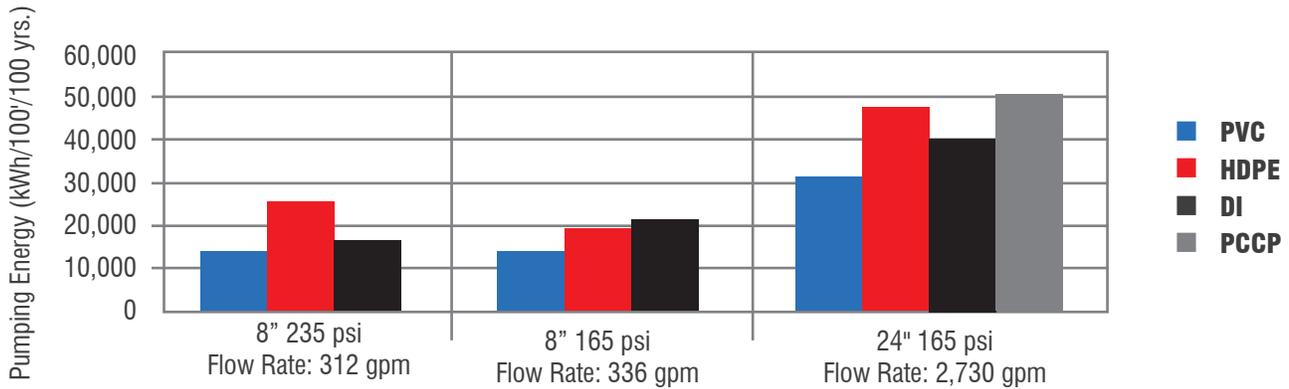
**FIGURE 10.1 : COMPARISON OF TOTAL 100-YEAR PUMPING ENERGY USE PER 100 FEET OF PIPE**

Note: Graph assumes replacement of HDPE pipe at 50 years, DI pipe at 50 years and PCCP at 75 years.

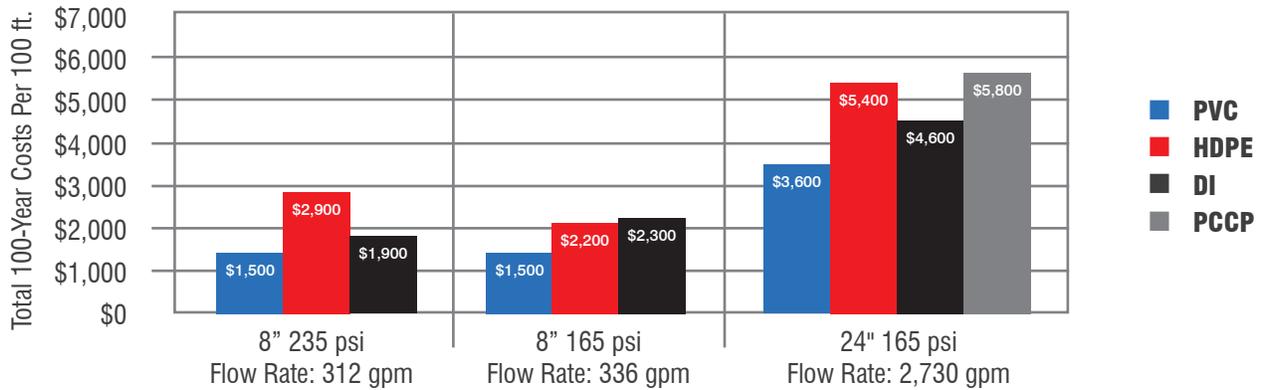
**FIGURE 10.2 : COMPARISON OF TOTAL 100-YEAR PUMPING ENERGY COSTS PER 100 FEET OF PIPE**

Note: Graph assumes replacement of HDPE pipe at 50 years, DI pipe at 50 years and PCCP at 75 years.

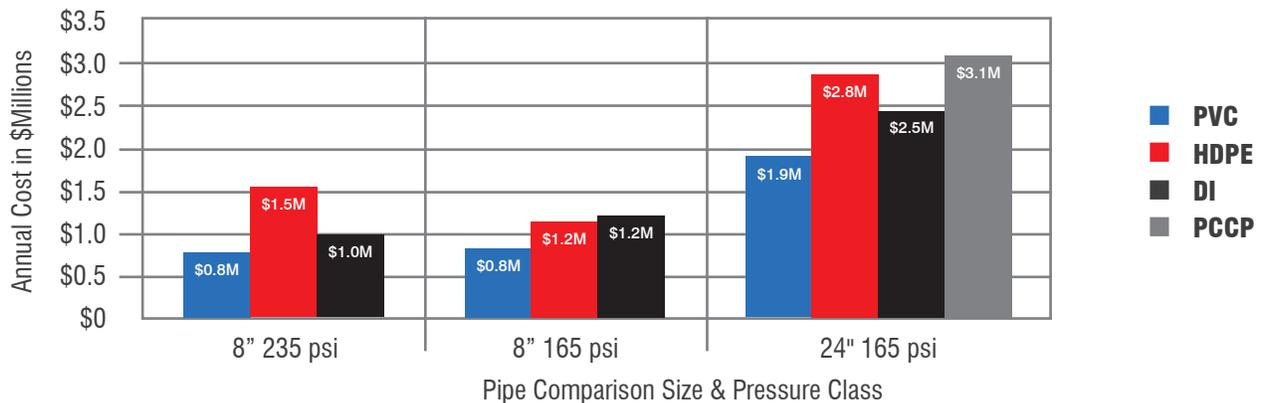
**FIGURE 10.3 : COMPARISON OF AVERAGE ANNUAL PUMPING ENERGY COSTS PER 1,000 MILES OF PIPE BASED ON 2 FPS VELOCITY**

Medium to large utilities typically have 1,000 miles of pipe so the potential savings of using PVC pipe can be significant. This study used a common flow generated by an equivalent 2 feet per second velocity in a PVC pipe for analysis of various pipe material options. Based on this, the 100-year average annual pumping cost savings were calculated. The savings for a utility using 8-inch PVC compared to equivalent DI pipe are up to \$440,000 annually. Savings for 8-inch PVC pipe versus HDPE are up to \$770,000 annually. Power costs for these 8-inch, 1,000-mile pipe networks are shown in Figure 10.3. Refer to the Appendix for the calculation methodology.

The average annual pumping cost savings for 8-inch pipe using PVC instead of DI can be up to \$440,000, and the savings using PVC instead of HDPE can be up to \$770,000.

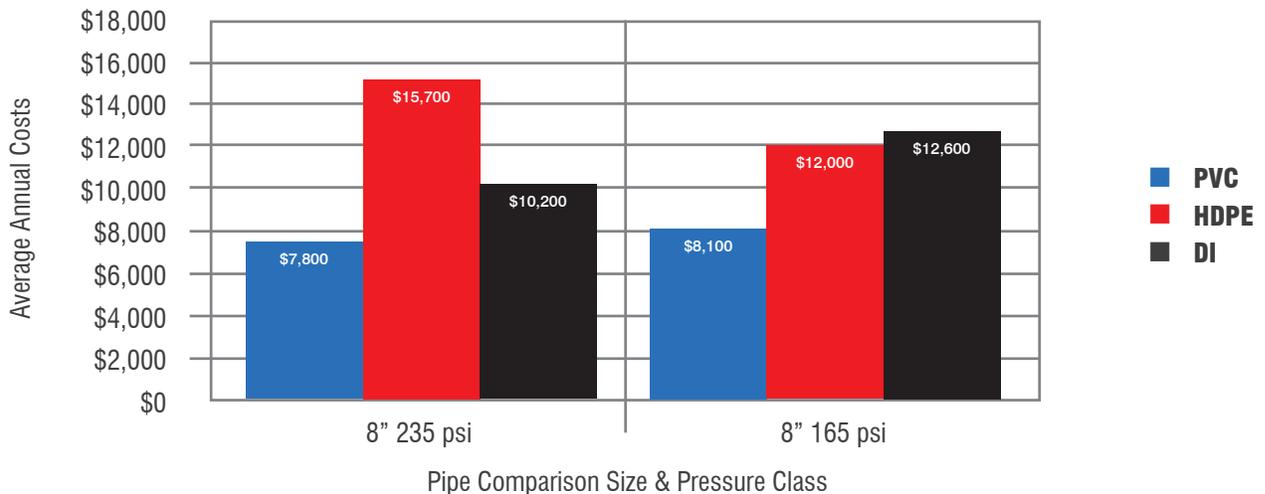
**FIGURE 10.4 : COMPARISON OF AVERAGE ANNUAL 100-YEAR PUMPING ENERGY COSTS PER 1,000 MILES OF PIPE BASED ON 0.4 FPS VELOCITY**

Note: Graph assumes replacement of HDPE and DI pipe at 50 years.

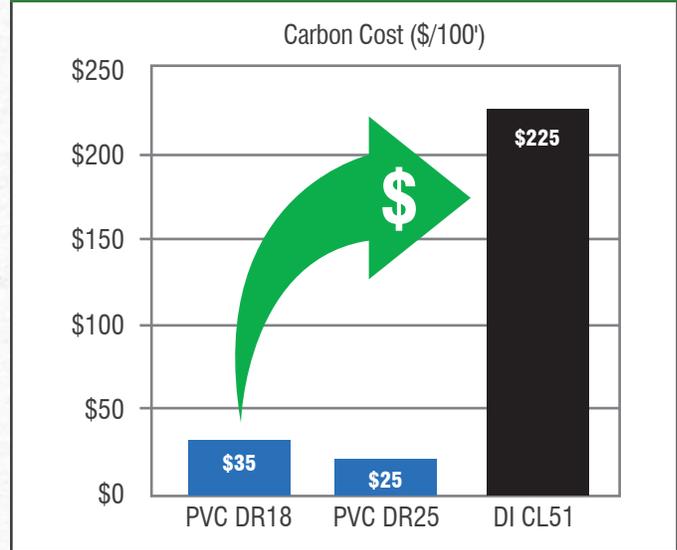
**FIGURE 10.6 : MONETIZED CARBON OUTPUT COMPARISON OF 100 FEET OF 8" PIPE**

Table 10.1 takes the cradle-through-installation output and converts it to carbon output for PVC and equivalent DI pipes. As shown in Figure 10.6, if carbon output for cradle-through-installation were penalized for 8-inch PVC and DI equivalent pipes at a functional length of 100 feet, PVC would be ranked lowest at \$25 or \$35 (depending on pressure class) compared to DI pipe at \$225. Each replacement for DI pipe over a 100-year period would require the payment of a new penalty. As discussed previously, DI pipe may only last 11-14 years in moderately corrosive soils and may need to be replaced 7 to 9 times over a 100-year period. This would mean a carbon penalty for DI pipe of \$1,575 to \$2,025 per 100 feet over 100 years compared to PVC at \$25 or \$35. The penalties over 100 years for a one mile pipeline could be \$83,160 to \$106,920 for DI pipe versus \$1,320 or \$1,848 for PVC.

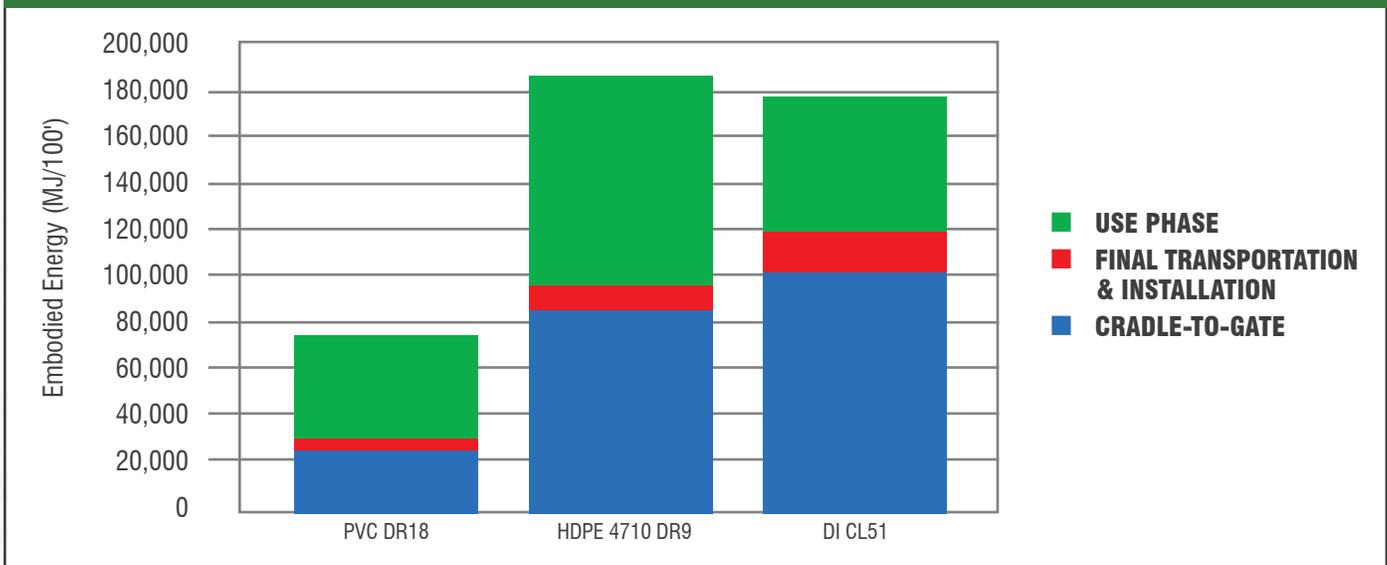
Figure 12.1 compares 8-inch PVC, HDPE and DI pipes with a pressure class at or equivalent to PVC DR18 PC235. As shown, the total 100-year embodied energy for PVC pipe is 61percent less than HDPE and 59 percent less than DI pipes.

**FIGURE 12.1 : TOTAL 100-YEAR EMBODIED ENERGY FOR 8” PVC DR18 EQUIVALENT PRESSURE PIPES**

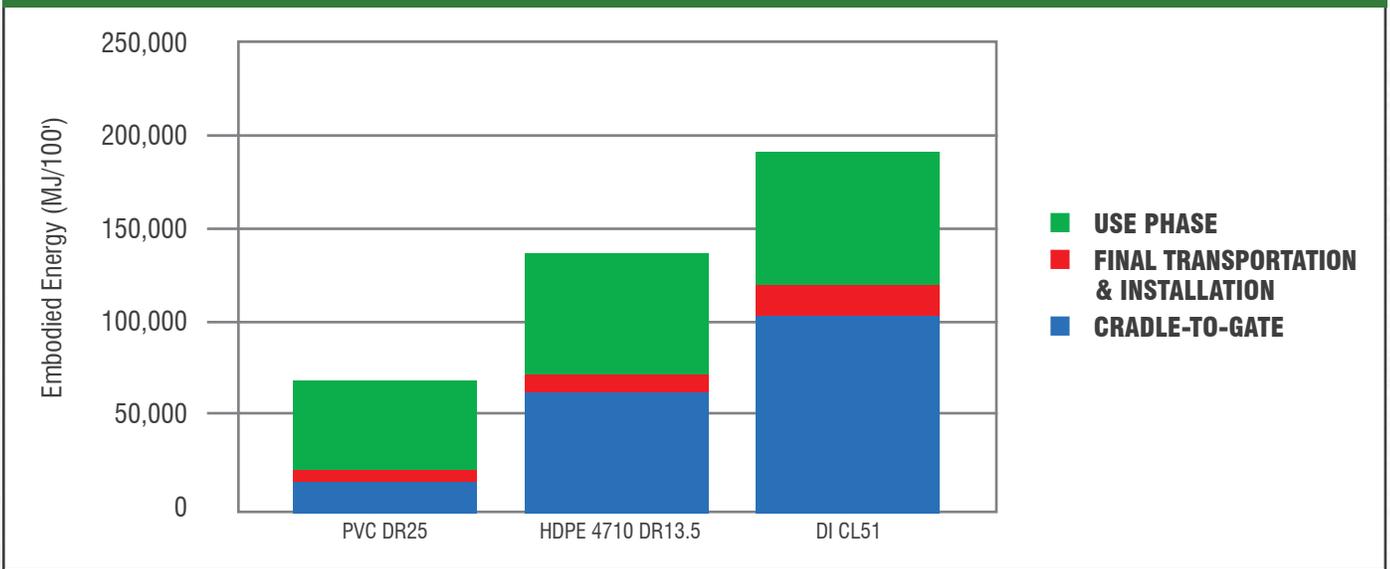
**FIGURE 12.2 : TOTAL 100-YEAR EMBODIED ENERGY FOR 8" PVC DR25 EQUIVALENT PRESSURE PIPES**

Figure 12.2 compares 8-inch PVC, HDPE and DI pipes with a pressure class at or equivalent to PVC DR25 PC165. As demonstrated, the total 100-year embodied energy for PVC pipe is 52 percent less than HDPE and 56 percent less than DI pipes.

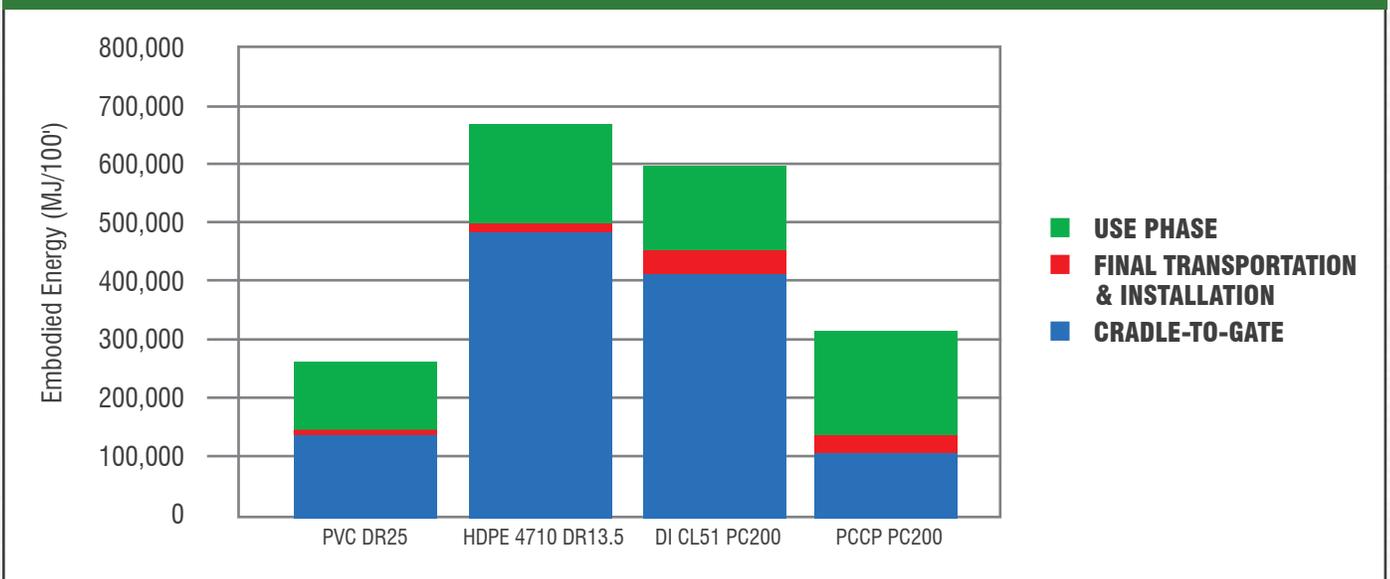
Figure 12.3 compares 24-inch PVC, HDPE and DI pipes with a pressure class at or equivalent to PVC DR25 PC165. As demonstrated, the total 100-year embodied energy for PVC pipes is 61 percent less than HDPE, 56 percent less than DI and 17 percent less than PCCP pipes.

**FIGURE 12.3 : TOTAL 100-YEAR EMBODIED ENERGY FOR 24" PVC DR25 EQUIVALENT PRESSURE PIPES**

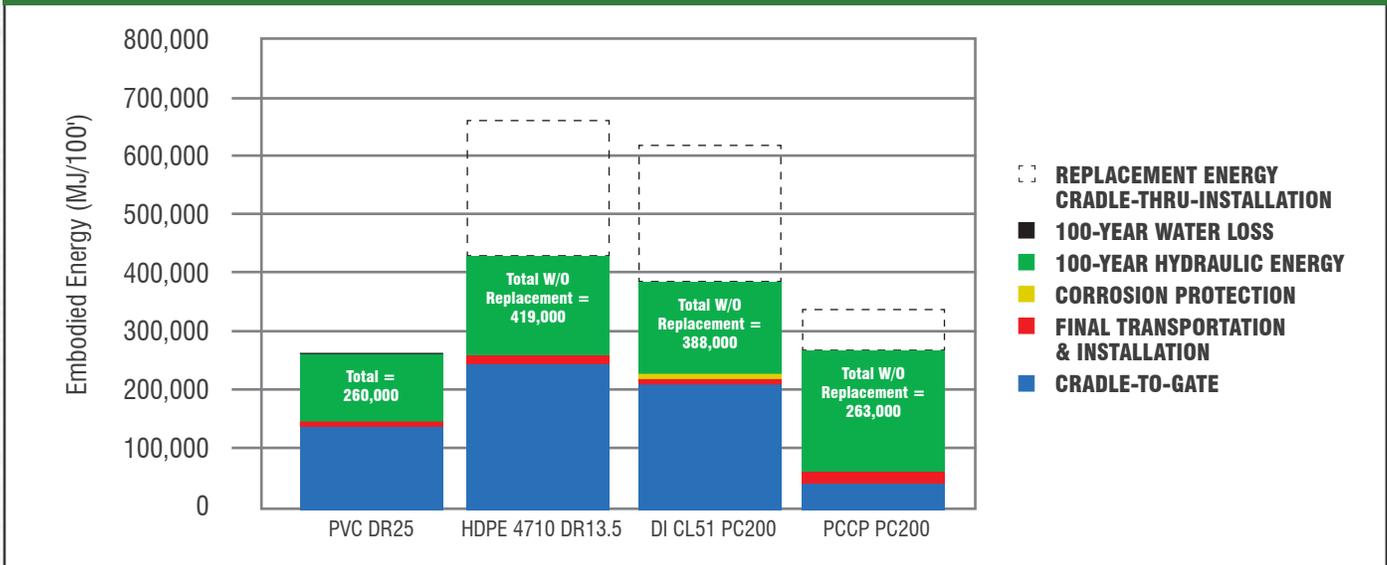
**FIGURE 12.4 : TOTAL 100-YEAR EMBODIED ENERGY FOR 24" PVC DR25 EQUIVALENT PRESSURE PIPES (HYDRAULIC ENERGY WITHOUT REPLACEMENT)**

Manufacturers of HDPE, DI and PCCP pressure pipes may claim that their pipes should not be replaced during the 100-year system design life and that this study unfairly represents their products. However, this study has demonstrated that these pipe products need replacement within 50 years. Moreover, even without replacement these pipe materials still have greater total embodied energy over 100 years than PVC pipe.

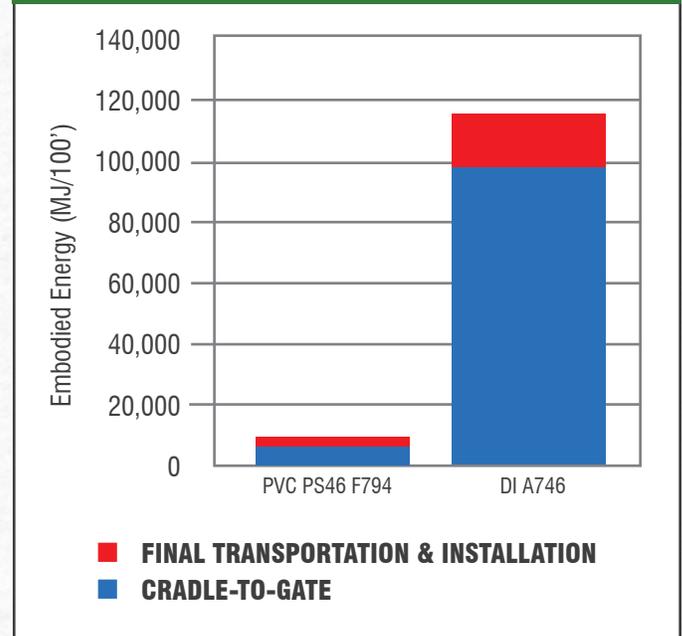
Figure 12.5 compares 8-inch PVC PS46 F794 profile-wall pipe and equivalent DI gravity pipe. The total 100-year embodied energy of PVC pipe is 91 percent less than equivalent DI sewer pipe.

**FIGURE 12.5 : TOTAL 100-YEAR EMBODIED ENERGY FOR 8" PVC PS46 F794 PROFILE-WALL EQUIVALENT GRAVITY PIPES**

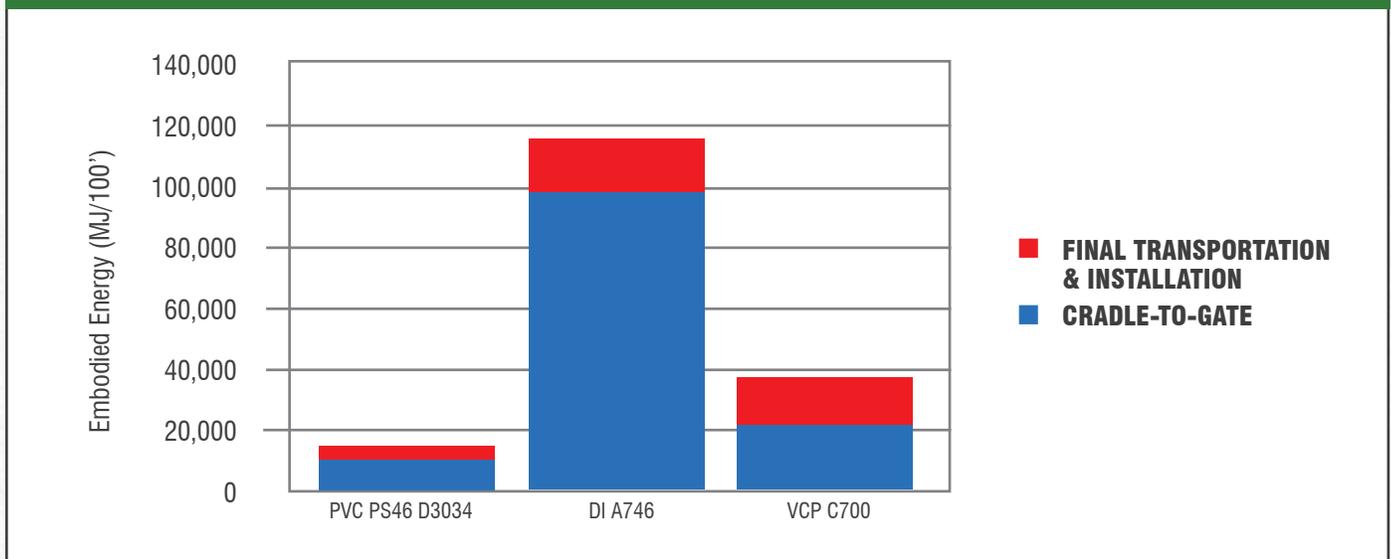
Figure 12.6 compares 8-inch PVC solid-wall, DI and VCP gravity pipe materials equivalent to PVC PS46 D3034 solid-wall pipe. The total 100-year embodied energy of PVC sewer pipe is 88 percent less than equivalent DI sewer pipe and 64 percent less than VCP pipe.

**FIGURE 12.6 : TOTAL 100-YEAR EMBODIED ENERGY FOR 8" PVC PS46 D3034 SOLID-WALL EQUIVALENT GRAVITY PIPES**

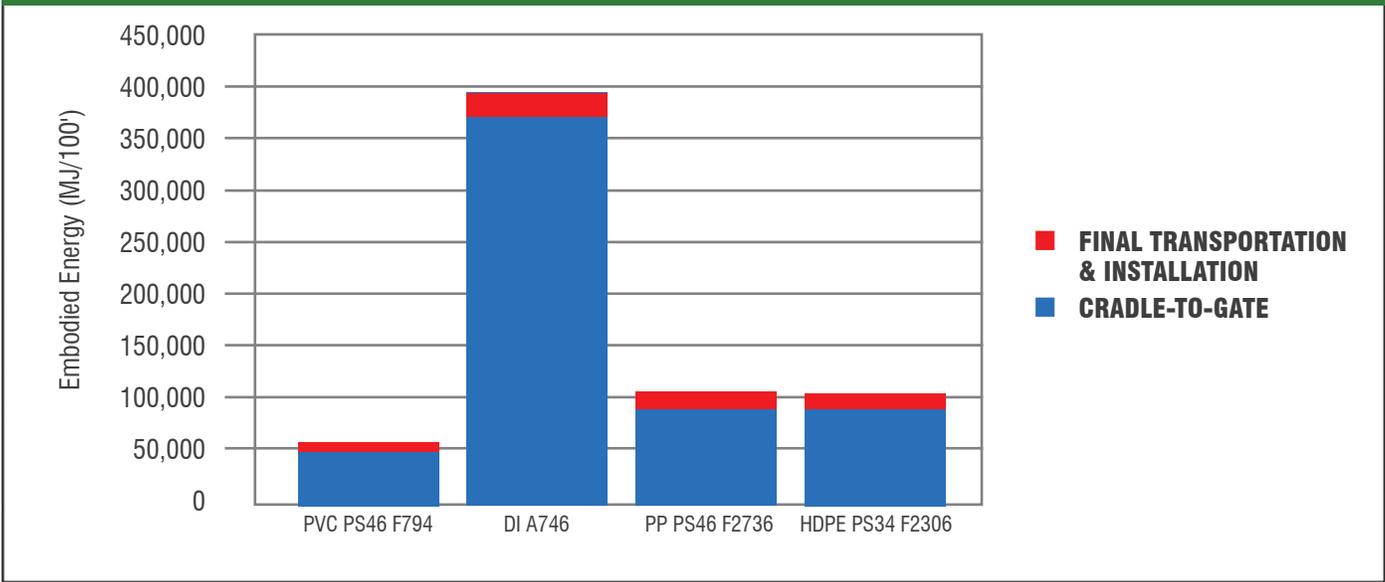
**FIGURE 12.7 : TOTAL 100-YEAR EMBODIED ENERGY FOR 24” PVC PS46 F794 PROFILE-WALL EQUIVALENT GRAVITY PIPES**

Figure 12.7 compares 24-inch PVC profile-wall, DI, PP and HDPE pipes equivalent to PVC PS46 F794 profile-wall pipe. The total 100-year embodied energy of PVC sewer pipe is 85 percent less than equivalent DI sewer pipe; 44 percent less than PP and 43 percent less than HDPE sewer pipes. It should be noted that the equivalent HDPE sewer pipe has a pipe stiffness that is 26 percent less than the pipe stiffness of PVC pipe.

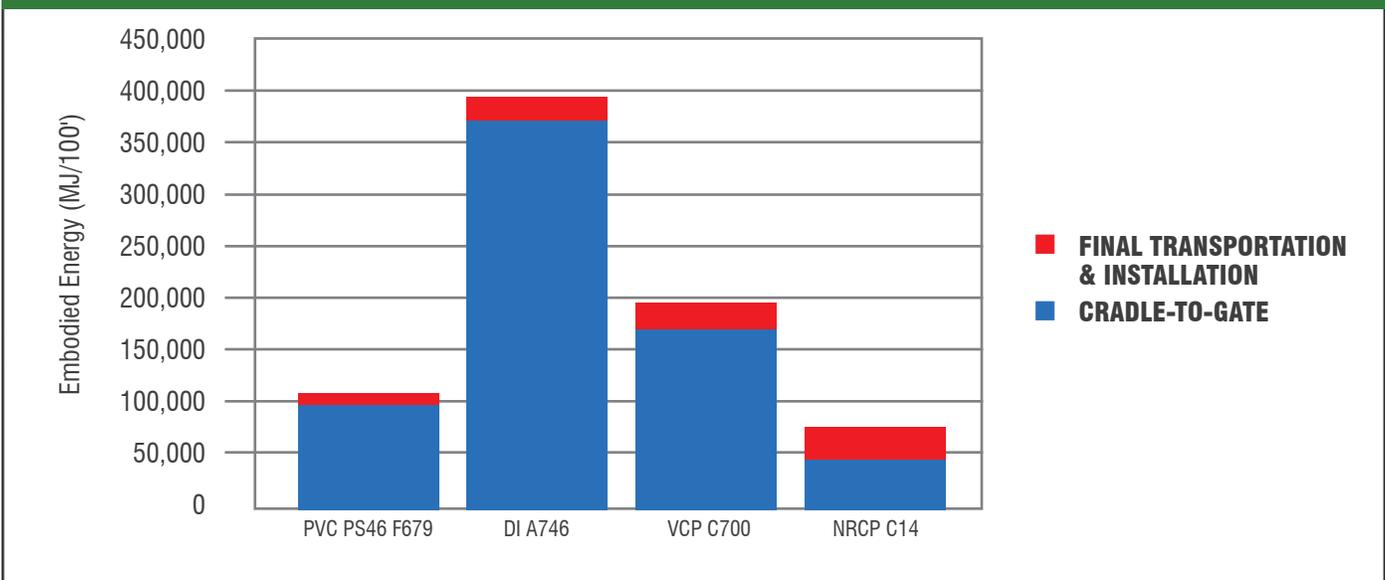
Figure 12.8 compares 24-inch PVC solid wall, DI, VCP and NRCP pipe materials equivalent to PVC PS46 F679 solid-wall pipe. The total 100-year embodied energy of PVC sewer pipe is more than 73 percent less than equivalent DI sewer pipe and 44 percent less than VCP.

**FIGURE 12.8 : TOTAL 100-YEAR EMBODIED ENERGY FOR 24” PVC PS46 F679 SOLID-WALL EQUIVALENT GRAVITY PIPES**

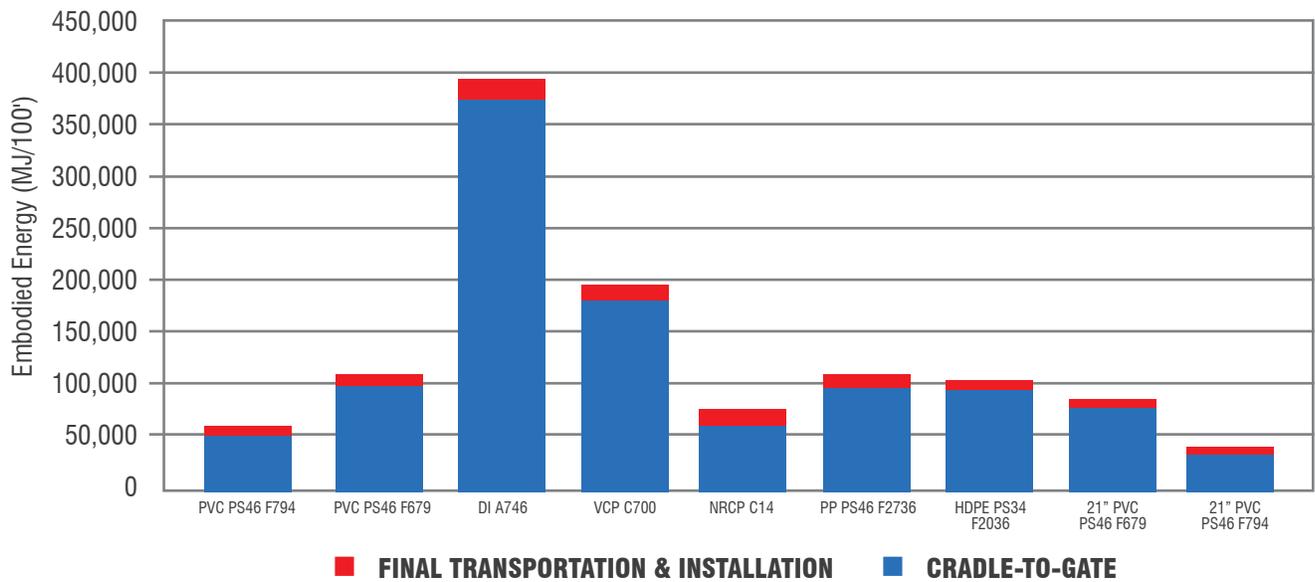
**FIGURE 12.9 : TOTAL 100-YEAR EMBODIED ENERGY FOR 24" PVC PS46 SOLID-WALL & PROFILE-WALL EQUIVALENT GRAVITY PIPES**

PVC has greater embodied energy compared to NRCP pipe, but NRCP is highly susceptible to deterioration from gases produced by wastewater. Due to this deterioration, NRCP would likely be required to be replaced two or more times during a 100-year design life for the pipe system. The corrosion of the pipe wall would also lead to increased infiltration and possibly pipe collapse. Increased infiltration significantly increases energy requirements and costs of a wastewater system. A pipe collapse not only requires large costs to repair, but could cause significant environmental contamination and endanger the safety of the public by undermining the support structure for buildings and roads built near sewer lines.

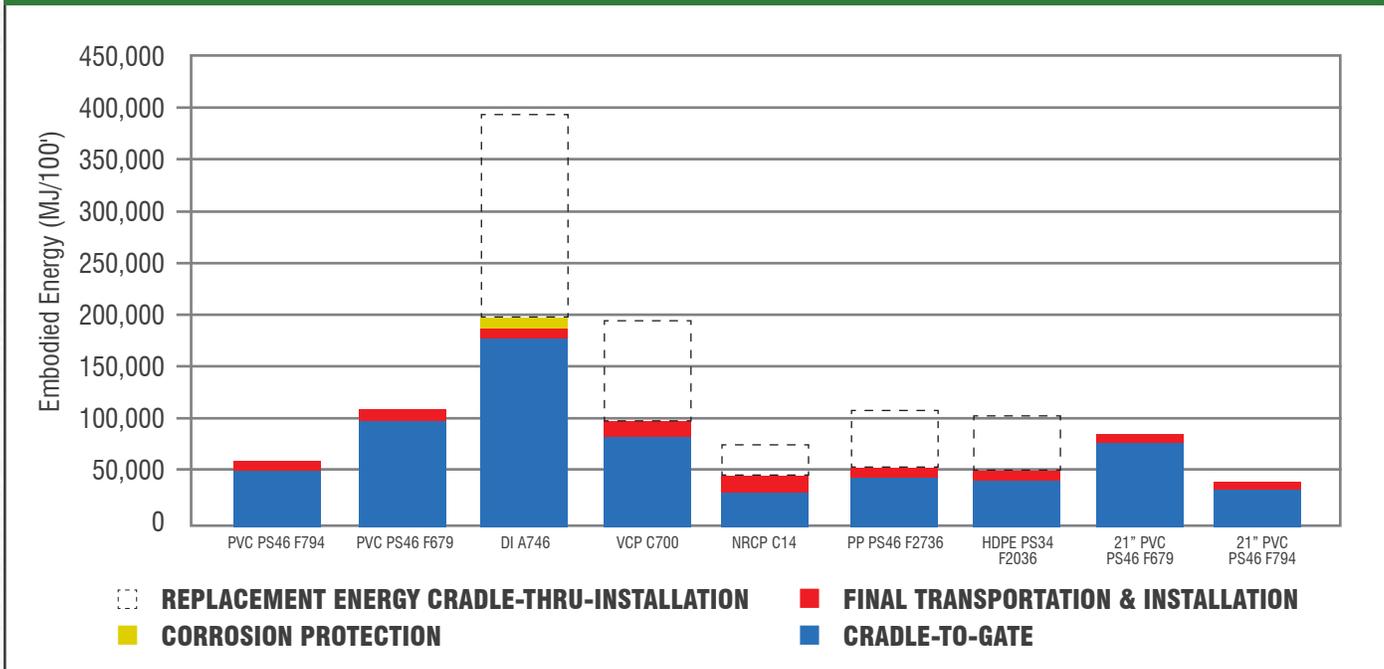
**FIGURE 12.10 : TOTAL 100-YEAR EMBODIED ENERGY FOR 24" PVC PS46 SOLID-WALL & PROFILE-WALL EQUIVALENT GRAVITY PIPES**

In order to be transparent, Figure 12.10 highlights the differences in embodied energy among the 24-inch gravity pipes without the needed replacements during the 100-year design life. Examination of Figure 12.10 reveals that 24-inch DI, VCP, PP and HDPE pipes have higher or equivalent 100-year embodied energies than PVC pipes even when replacement embodied energies are not considered.
