Sustainable**Solutions**  
CORPORATION

**APRIL 2017**

## **LIFE CYCLE ASSESSMENT OF PVC WATER AND SEWER PIPE AND COMPARATIVE SUSTAINABILITY ANALYSIS OF PIPE MATERIALS**

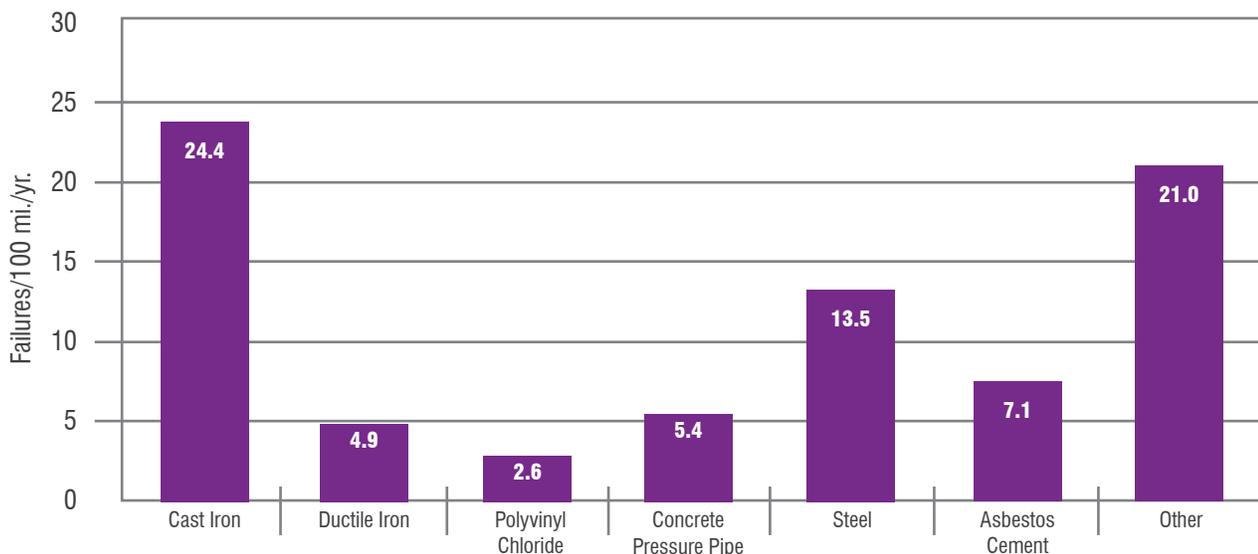
iron and 4.9 breaks for ductile iron as shown in Figure A.1.<sup>151</sup> The same study shows that for Canada the comparable figures were 0.7 breaks per 100 miles per year for PVC versus 35 for cast iron and 15.2 for DI. A study by the National Research Council (NRC) of Canada reported that historical break rates per 100 miles of pipe for ductile iron were 15.87. PVC exhibited only 1.17 breaks per 100 miles of pipe. The NRC report showed that ductile iron pipe had 13.57 times more breaks than PVC pipe. This difference in break rates results in significant repair cost differences for PVC and ductile iron, as shown in Figure A.2. Subsequent research in 1992 confirmed 14.9 breaks per 100 miles for DI and only 1.45 for PVC pipe. In 1993, additional data reported that DI pipe had 15.7 breaks per 100 miles, while PVC had 0.8 breaks per 100 miles.<sup>152</sup>

**FIGURE A.1 : FAILURE RATES OF EACH PIPE MATERIAL PER 100 MILES OVER A ONE-YEAR PERIOD**

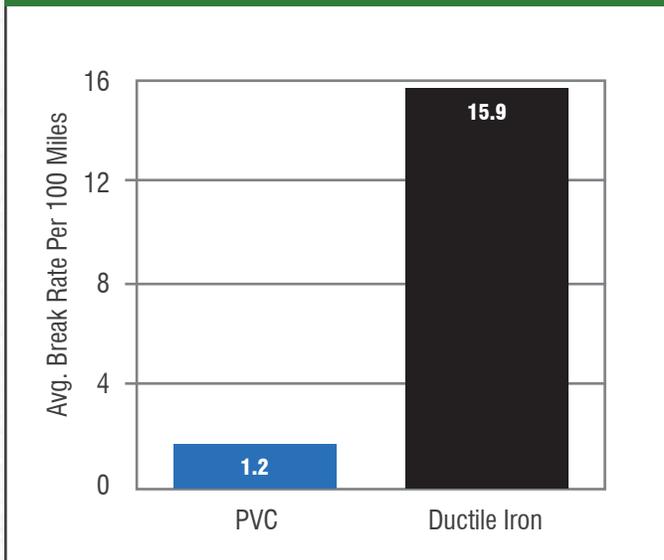
**FIGURE A.2 : NRC CANADA PVC AND DI PIPE BREAK RATES**

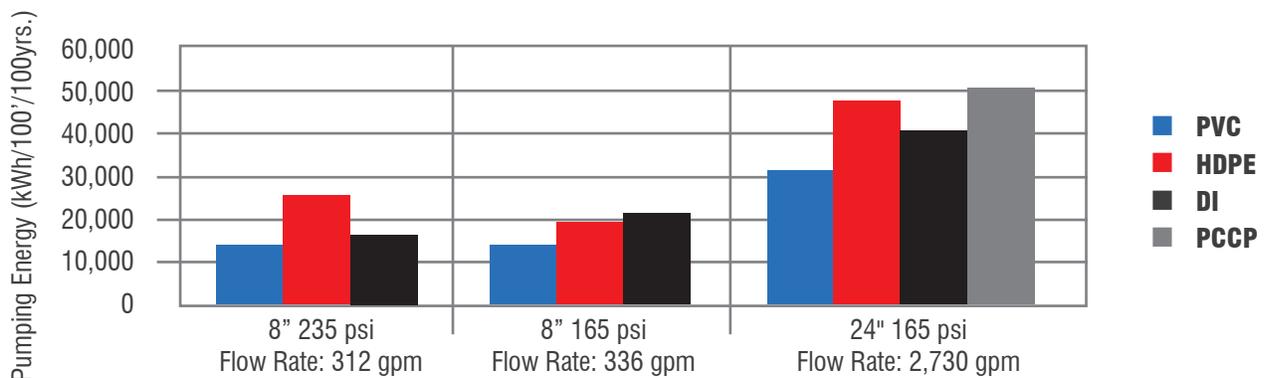
**FIGURE A.3 : TOTAL 100-YEAR PUMPING ENERGY USE PER 100 FEET OF PIPE**

Note: Graph assumes replacement of HDPE pipe at 50 years, DI pipe at 50 years and PCCP at 75 years.

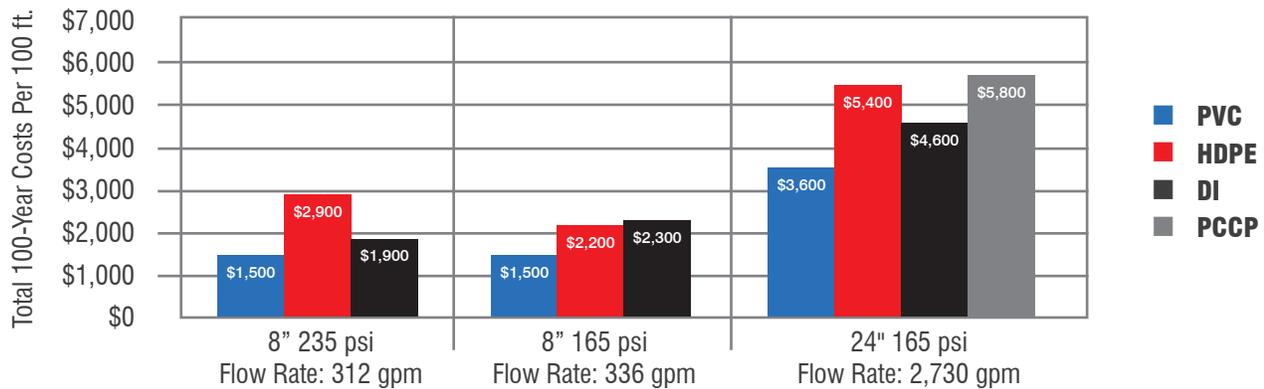
**FIGURE A.4 : TOTAL 100-YEAR PUMPING ENERGY COSTS PER 100 FEET OF PIPE**

Note: Graph assumes replacement of HDPE pipe at 50 years, DI pipe at 50 years and PCCP at 75 years.

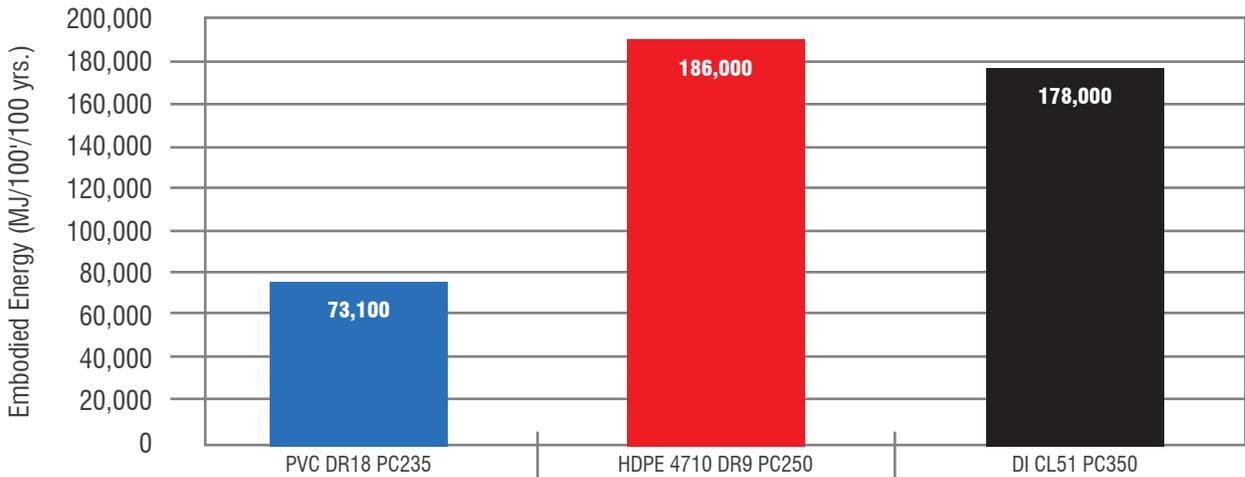
**FIGURE A.5 : 8" PVC DR18 EQUIVALENT PIPES: 100-YEAR TOTAL EMBODIED ENERGY**

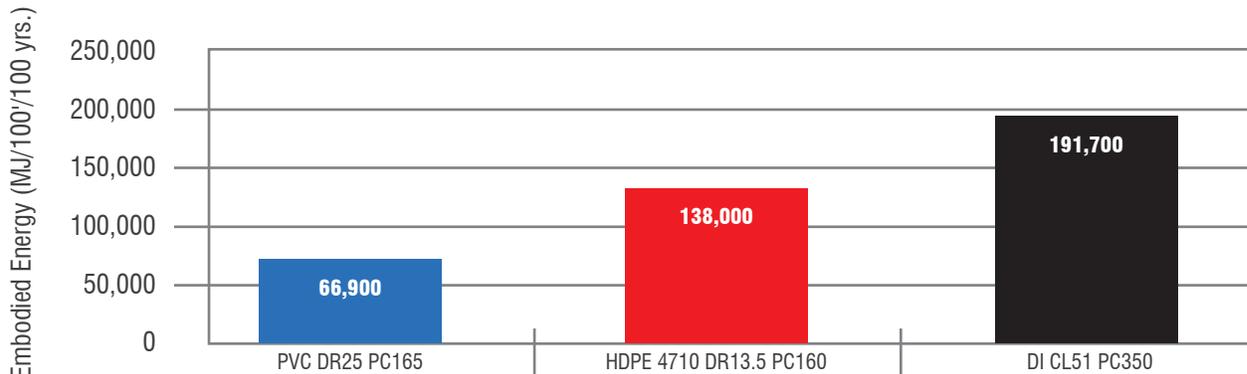
**FIGURE A.6 : 8" PVC DR25 EQUIVALENT PIPES: 100-YEAR TOTAL EMBODIED ENERGY**

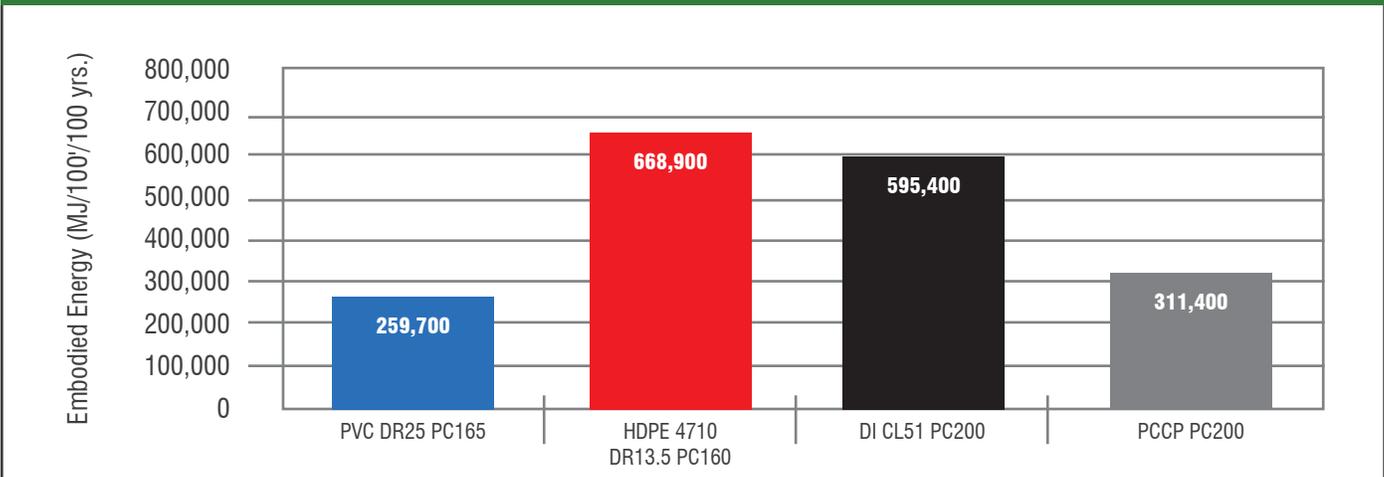
**FIGURE A.7 : 24" PVC DR25 EQUIVALENT PIPES: 100-YEAR TOTAL EMBODIED ENERGY**

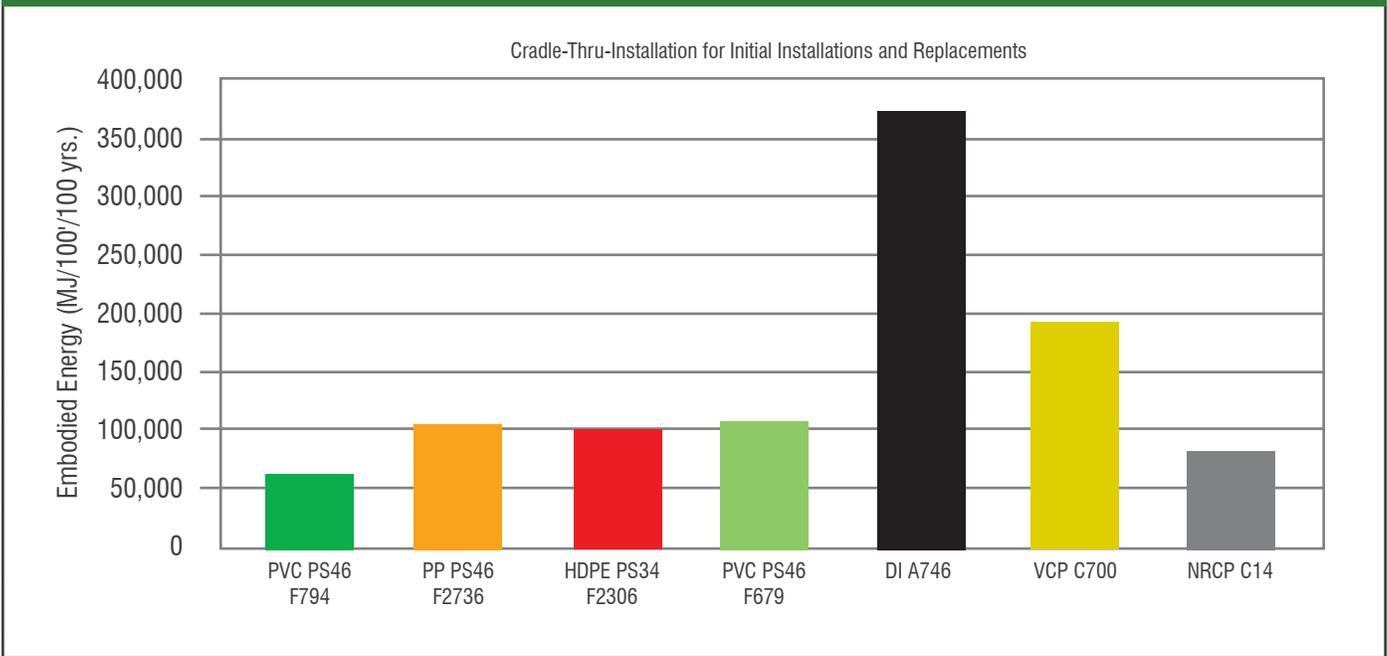
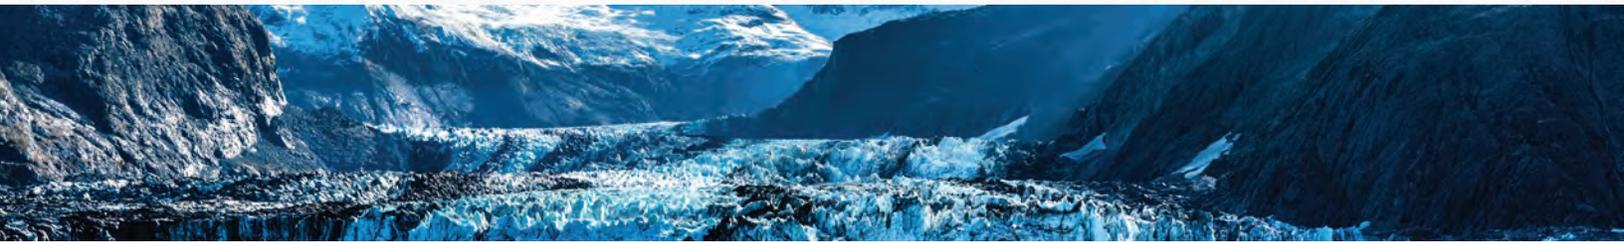
**FIGURE A.8 : TOTAL 100-YEAR EMBODIED ENERGY FOR 24" GRAVITY PIPE PRODUCTS**

The total 100-year embodied energy values for the gravity pipes used in this study are listed in Table A.7 and shown in Figures A.8 and A.9.

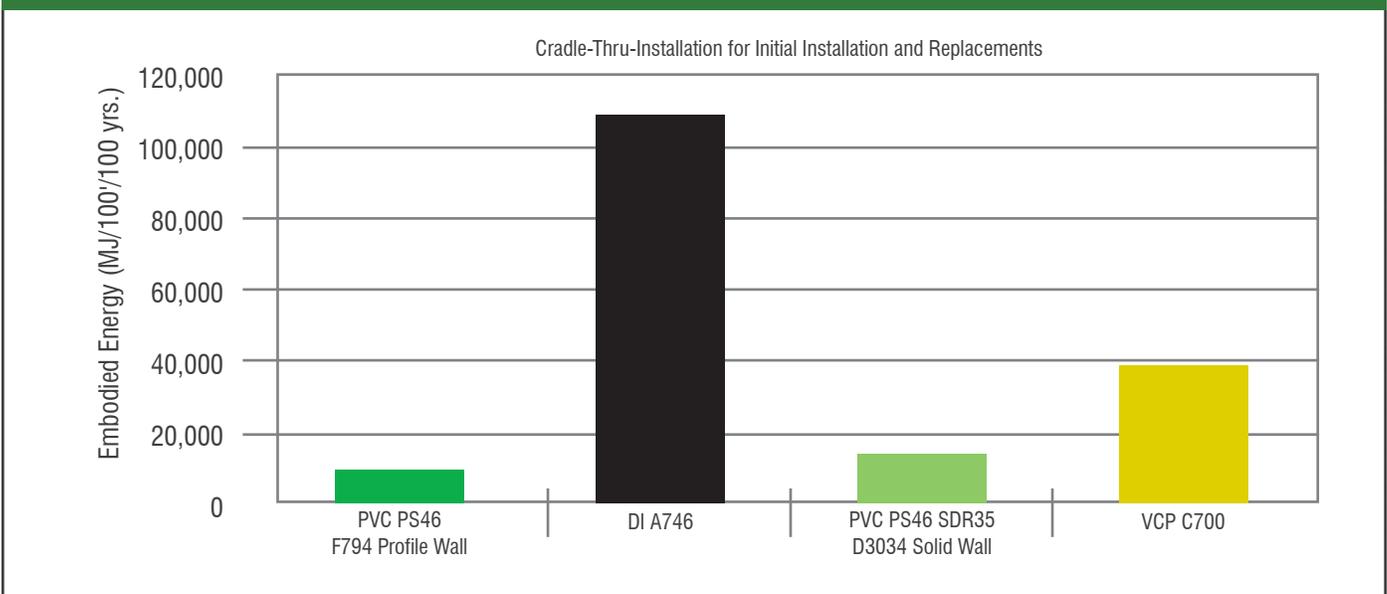
**FIGURE A.9 : TOTAL 100-YEAR EMBODIED ENERGY FOR 8" GRAVITY PIPE PRODUCTS**

Using the same slope as the pipe with the steepest slope required to achieve a flow velocity of 2 fps, volumetric flows for the other comparison pipes were calculated and compared. In addition, for the 24-inch pipe size options, the next size smaller PVC pipe was evaluated.

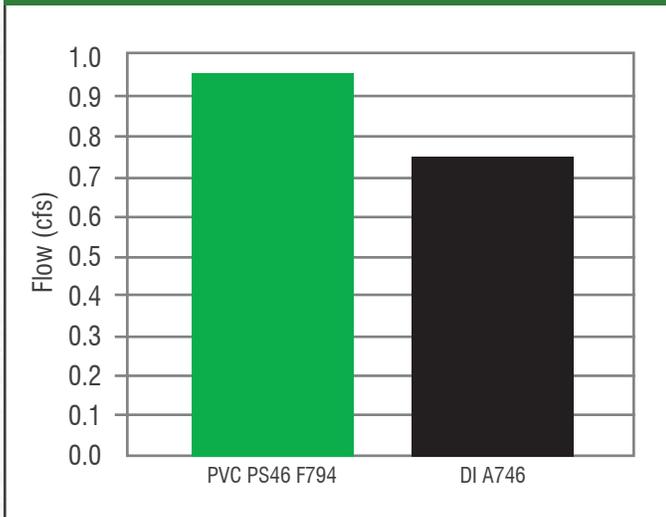
**FIGURE A.10 : 8" PROFILE-WALL PVC GRAVITY PIPE FLOW COMPARISONS WITH EQUIVALENT SLOPE**

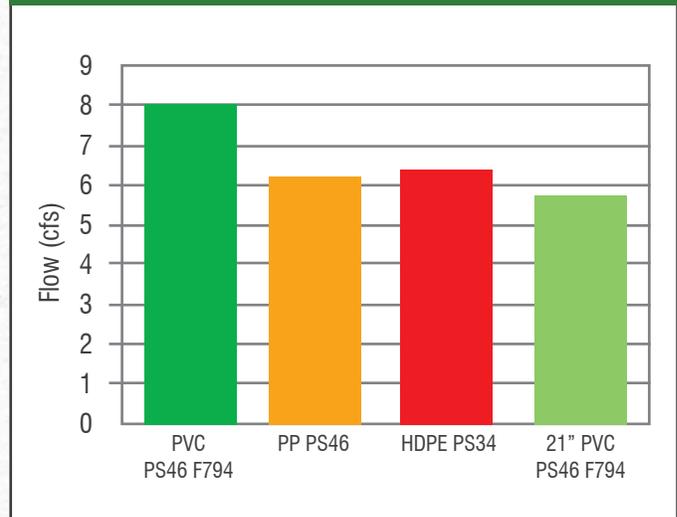
**FIGURE A.11 : 24" PROFILE-WALL PVC GRAVITY PIPE FLOW COMPARISONS WITH EQUIVALENT SLOPE**

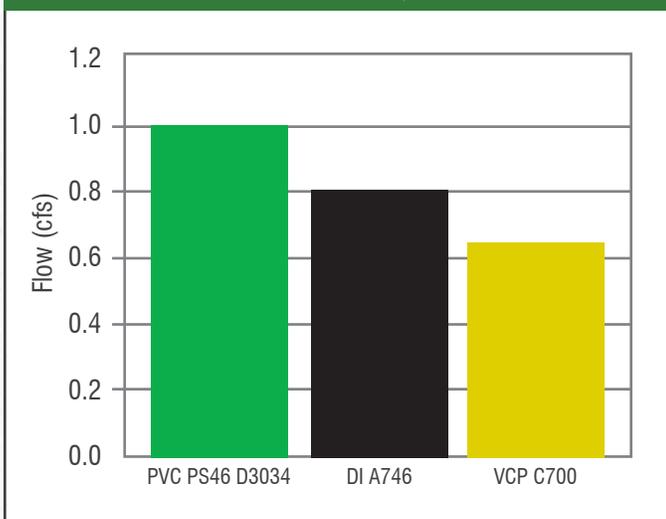
**FIGURE A.12 : 8" SOLID-WALL PVC GRAVITY PIPE FLOW COMPARISONS WITH EQUIVALENT SLOPE**

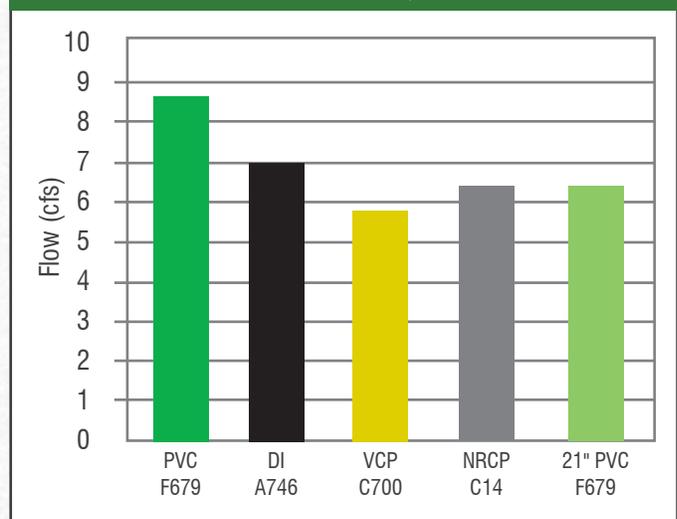
**FIGURE A.13 : 24" SOLID-WALL PVC GRAVITY PIPE FLOW COMPARISONS WITH EQUIVALENT SLOPE**

Figure A.13 compares PVC ASTM F679 pipe to other 24-inch solid-wall products. PVC has over 24% more capacity than DI pipe, over 50% more than clay pipe, and 35% more than non-reinforced concrete pipe (NRCP) on the same slope.

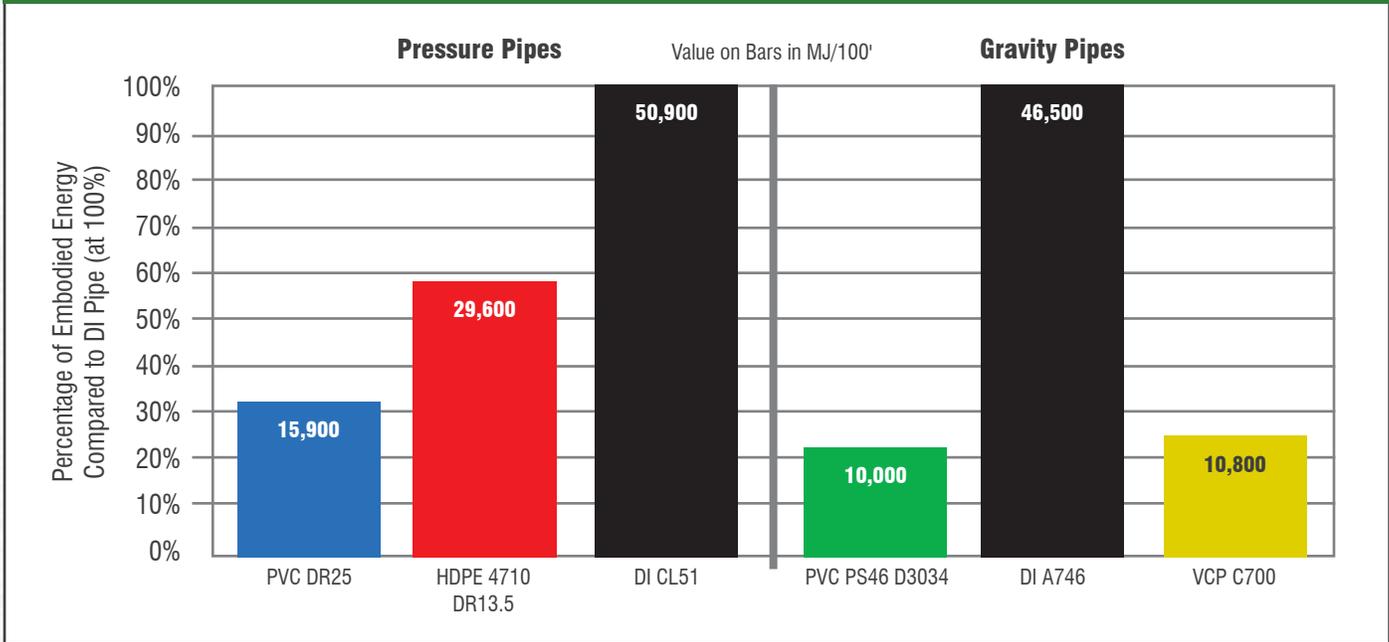
**FIGURE A.14 : CRADLE-TO-GATE EMBODIED ENERGY COMPARISONS FOR EQUIVALENT 8" PIPES (MJ/100')**

Note: Total 100-year embodied energy includes cradle-through-installation, required replacements and corrosion protection.

required to be replaced during the 100-year life cycle, the embodied energy of that material is increased accordingly. The total cradle-to-gate embodied energy for 8-inch PVC PS46 D3034 gravity pipe is 83% less than cement-lined DI pipe when replacements are considered during the 100-year design life.

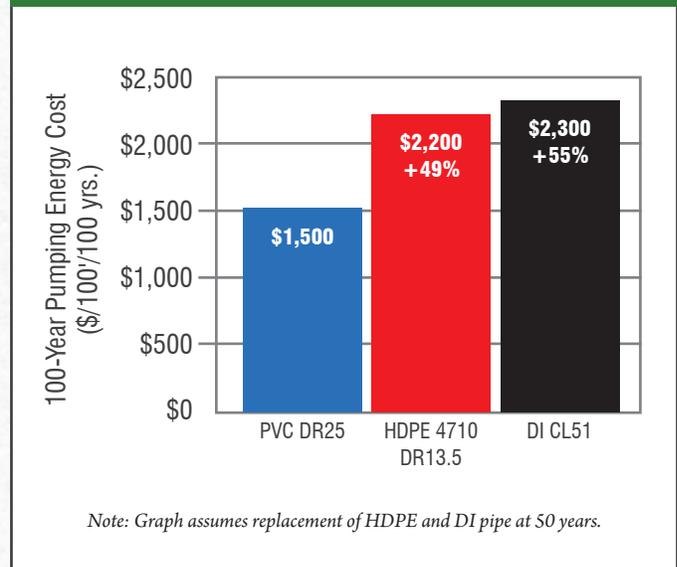
**FIGURE A.15 : PUMPING ENERGY COST OF 8" PVC DR25 EQUIVALENT PIPES OVER A 100-YEAR LIFE CYCLE**

Note: Graph assumes replacement of HDPE and DI pipe at 50 years.

In Figure A.15 8-inch PVC DR25 water pipe has a lower 100-year life cycle pumping cost per 100 feet because of its lower pumping energy demand than HDPE and ductile iron piping materials. The energy required to pump water through a pressurized pipe system over the life of the pipe is a significant source of potential environmental impacts.

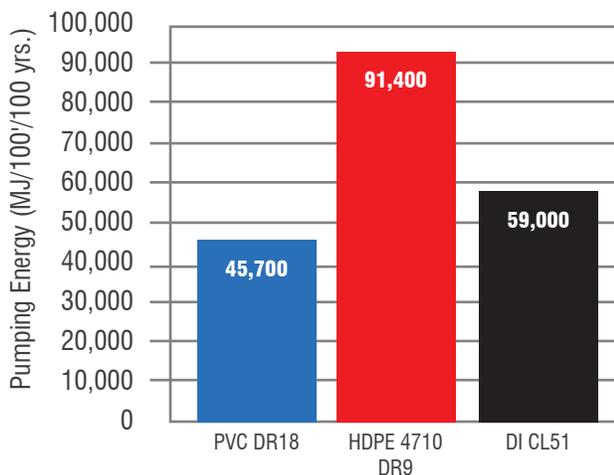
**FIGURE A.16 : 8" PVC DR18 EQUIVALENT PIPES  
100-YEAR PUMPING ENERGY**

Note: Graph assumes replacement of HDPE and DI pipe at 50 years.

Figure A.16 compares 8-inch PVC DR18 pipe with similar pressure class pipe materials. The deterioration of the cement-lining and corrosion of DI pipe causes greater pumping energy use over the life cycle than PVC pipe. Because of the lower tensile strength, HDPE pipe has thick walls and smaller internal diameter, resulting in a diminished conveyance area and increased pumping energy over the life cycle.

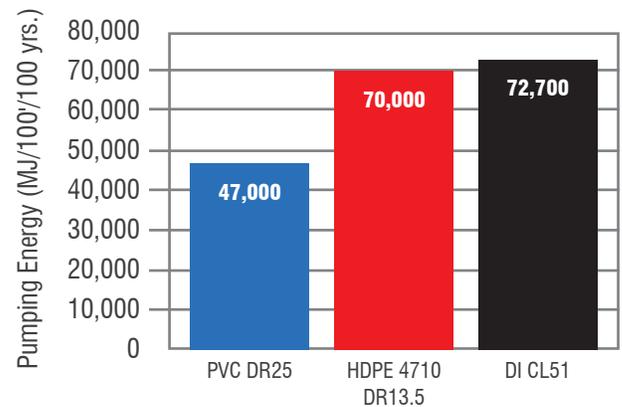
**FIGURE A.17 : 8" PVC DR25 EQUIVALENT PIPES  
100-YEAR PUMPING ENERGY**

Note: Graph assumes replacement of HDPE and DI pipe at 50 years.

Figure A.17 illustrates the difference in the life cycle pumping energy required for 8-inch PVC DR25 pipe compared to DI and HDPE pipes. Again, the deterioration of the mortar lining and corrosion of the DI pipe and the smaller conveyance area of HDPE pipe result in higher life cycle pumping energy requirements and costs for those materials.

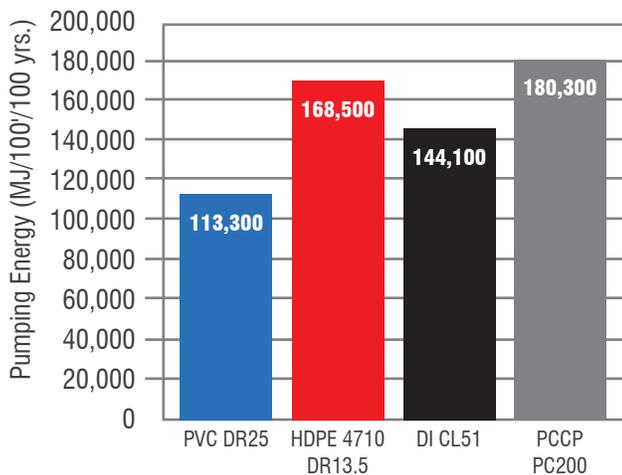
**FIGURE A.18 : 24" PVC DR25 EQUIVALENT PIPES  
100-YEAR PUMPING ENERGY**

*Note: Graph assumes replacement of HDPE pipe at 50 years, DI pipe at 50 years and PCCP at 75 years.*

Figure A.18 compares 24-inch PVC DR25 pipe with similar pressure classes of DI, HDPE and PCCP piping. When the diameter and deterioration of friction factor of all pipe materials are considered, 24-inch PVC pipe is the clear, sustainable choice for efficiency in pumping energy.

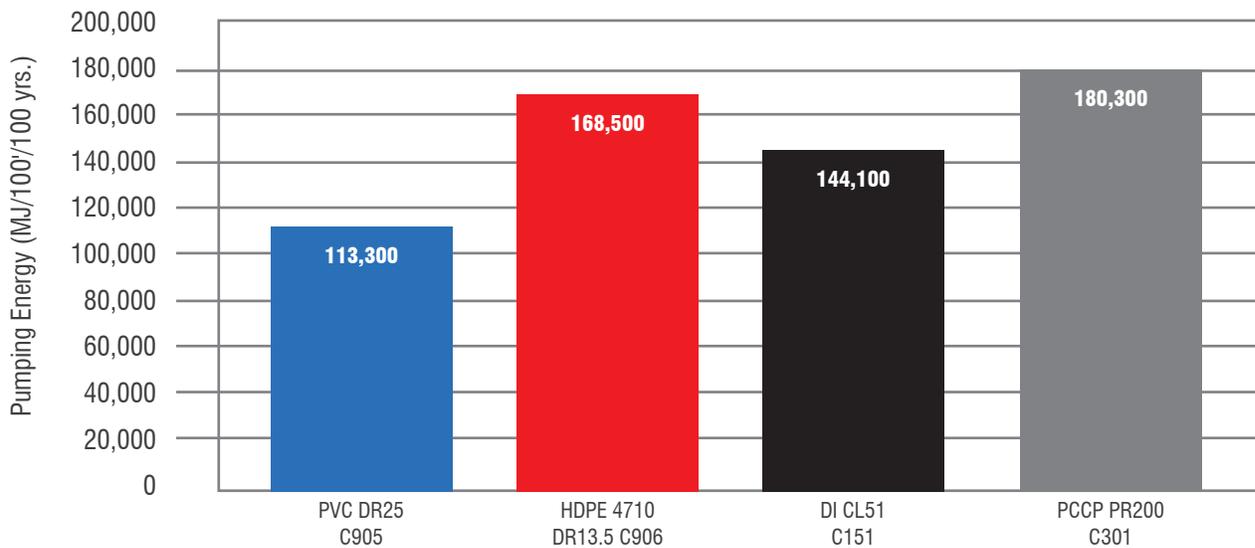
**FIGURE A.19 : 24" PVC DR25 EQUIVALENT PIPES 100-YEAR PUMPING ENERGY**

*Note: Graph assumes replacement of HDPE pipe at 50 years, DI pipe at 50 years and PCCP at 75 years.*

A review of existing publicly available LCA literature shows that PVC pipe has lower embodied impacts and use stage impacts compared to other pipes. Pumping energy, however, is the largest component of the total 100-year life cycle embodied energy of a piping material. Therefore, pumping efficiency over time is critical. Figures A.19 and A.20 illustrate the differences in pumping energy of various pipe materials. Figure A.19 shows the pumping energy of 24-inch pipe based on the service life as determined in this study.

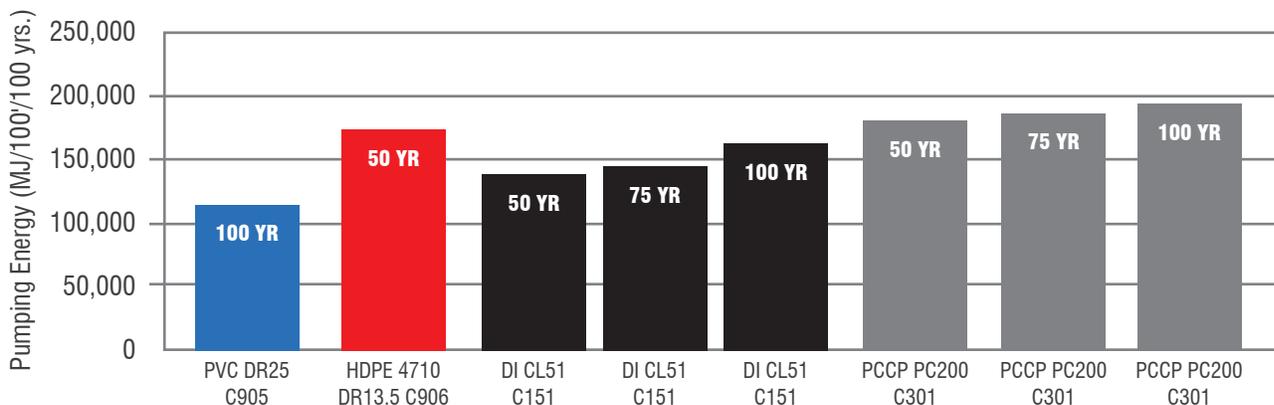
**FIGURE A.21 : 8" PVC DR18 EQUIVALENT PIPES TOTAL 100-YEAR PUMPING COSTS USING DIFFERING PIPE LIVES (\$/100'/100 YRS.)**

Figures A.20, A.21 and A.22 use differing pipe lives/service lives for iron and concrete pipes to provide utility professionals with accurate comparative pumping energy and cost estimates for a 100-year period. This requires a redefinition of traditional notions of pipe service life. For much of the time that iron and concrete pipes have been considered to be “in service,” they in fact were not since they were not performing as designed. For a good portion of the time they are in use, they are prone to water main breaks, water loss, water quality issues as well as higher maintenance and operating costs due to corrosion. This affects pumping efficiency significantly.

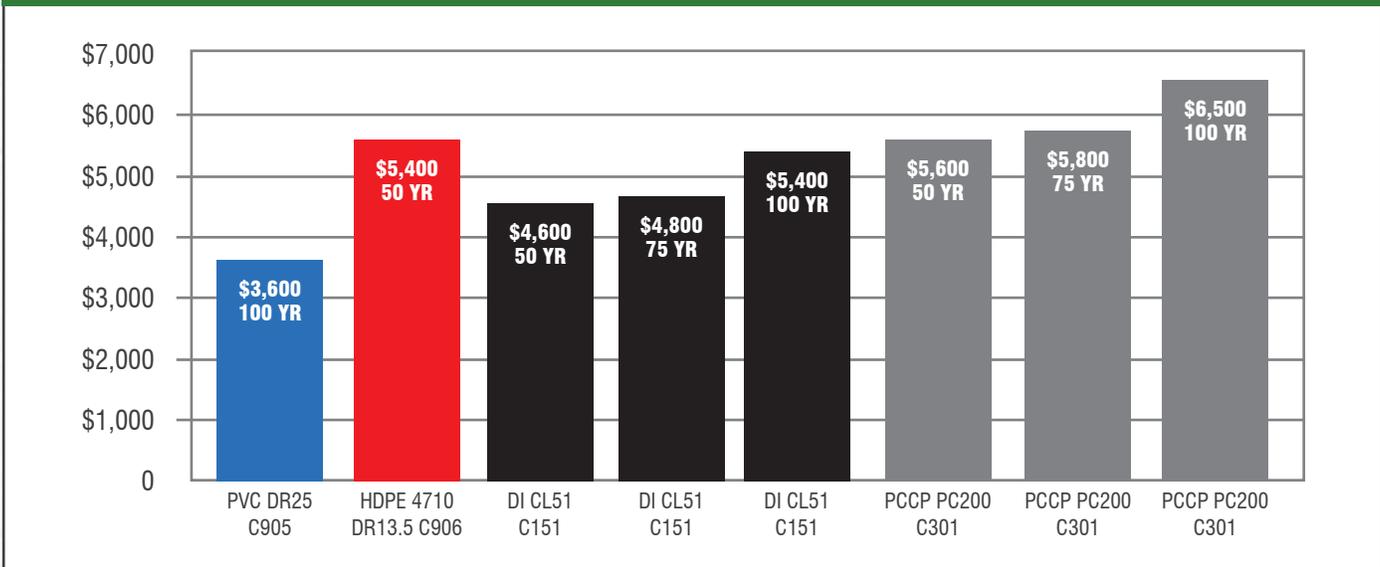
**FIGURE A.22 : 24" PVC DR25 EQUIVALENT PIPES TOTAL 100-YEAR PUMPING COSTS USING DIFFERING PIPE LIVES (\$/100'/100 YRS.)**

Figure A.20 demonstrates the increase in pumping energy beyond service life for corrosion-prone piping materials like DI and PCCP. Figures A.21 and A.22 show that using a pipe material beyond its service life results in higher pumping costs. This study has evaluated HDPE and DI pipe's longevity at 50 years and PCCP's at 75 years.

In Figures A.20, A.21 and A.22, the 50-year and 75-year bars take into account that new pipe is installed at 50 and 75 years, respectively, into the 100-year system design life. This resets the friction factor to that of new pipe at that time. For the 100-year bars, new pipe is not installed so the friction factor is not reset during the 100-year period.

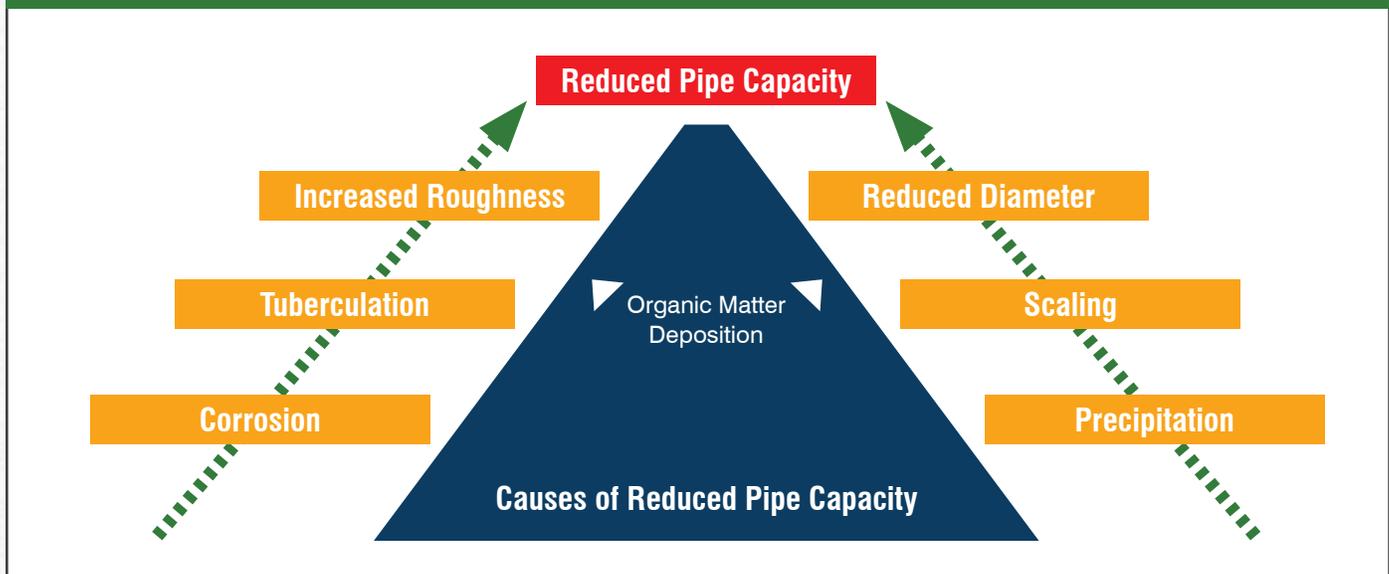
**FIGURE A.23 : INTERNAL CORROSION AND TUBERCULATION OF WATER MAINS: CAUSES AND IMPACTS ON PERFORMANCE**

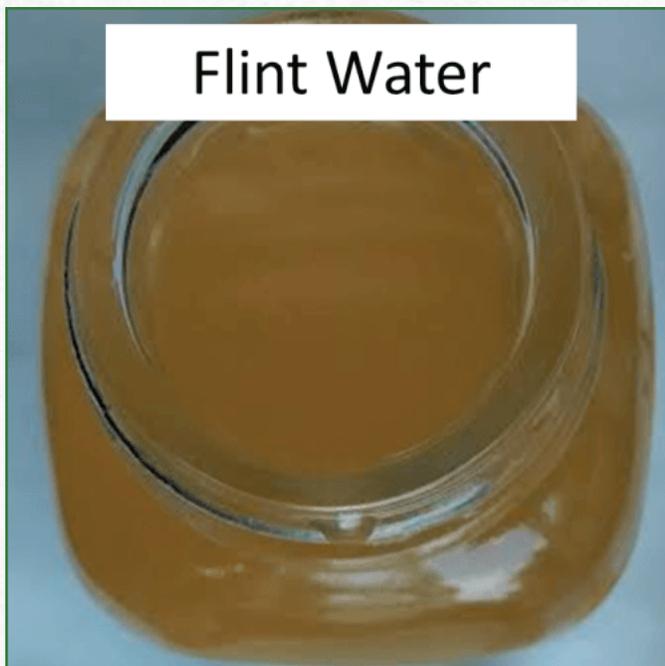
**FIGURE A.24 : IRON CORROSION CAUSES "RED" OR RUSTY WATER**

Iron corrosion causes water to become a rusty/red color. In Flint, Michigan, residents had been complaining of "red" or discolored water. See Figure A.24 for an example of Flint drinking water affected by corrosion and Figure A.25 for examples of corroded iron water pipes dug up in Flint.<sup>223</sup> Iron in water can make it difficult for municipalities to meet federal standards because iron corrosion consumes chlorine which makes it more likely that bacteria will grow in the water. It is possible that, with the existing unlined iron pipe system in Flint and the relatively low water demand (due to declining population and loss of businesses) it will be very difficult to meet federal standards for minimum chlorine levels, regardless of what is done to treat the water.<sup>224</sup> See Figure A.26 for an example of how chlorine levels decrease when exposed to iron.<sup>225</sup>

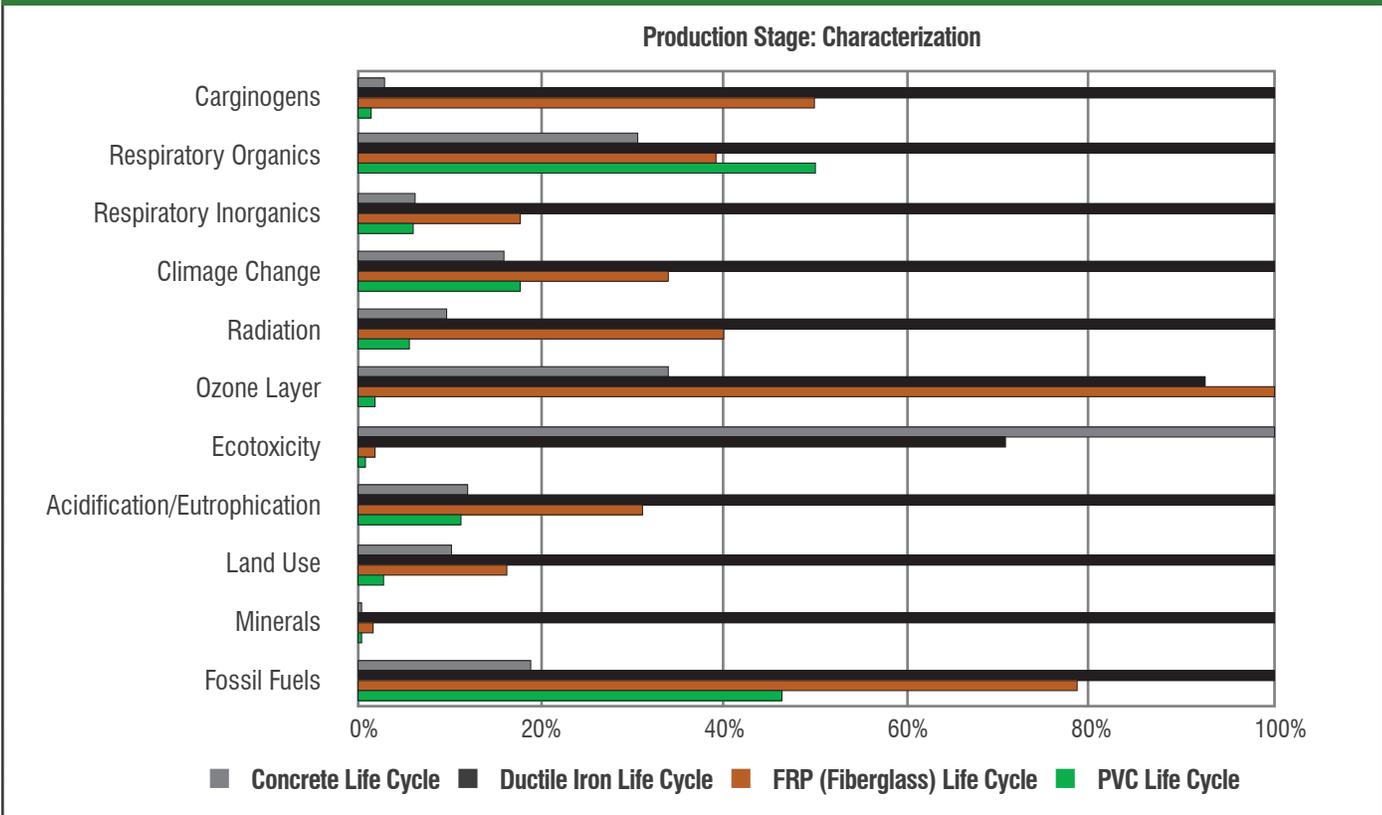
**FIGURE A.27 : CHARACTERIZATION GRAPH FOR LIFE CYCLE COMPARISON FOR ALL PIPING MATERIALS**
